UNITED STATES
DEPARTMENT OF THE INTERIOR
GEOLOGICAL SURVEY

FLOODS FROM DAM FAILURES

By John E. Costa

Open-File Report 85-560

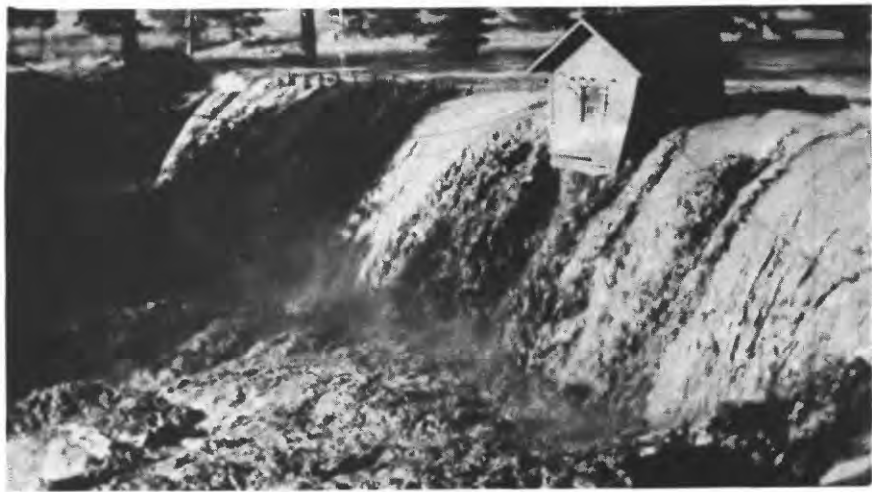
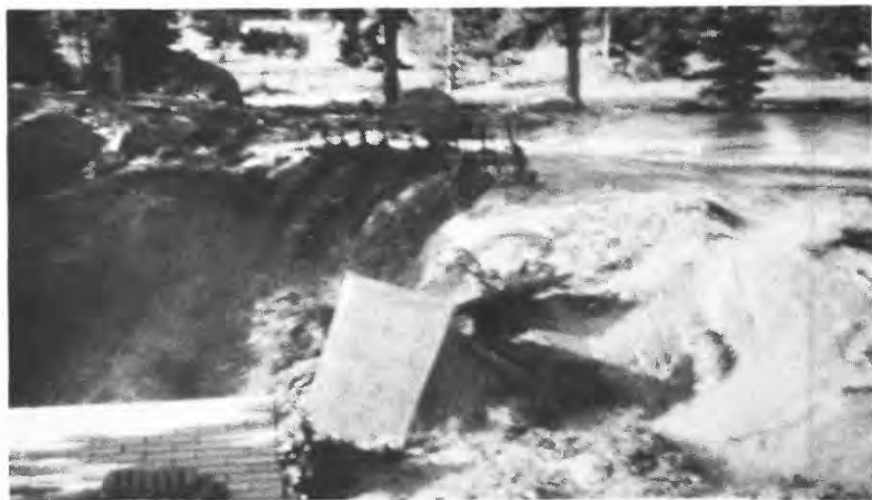
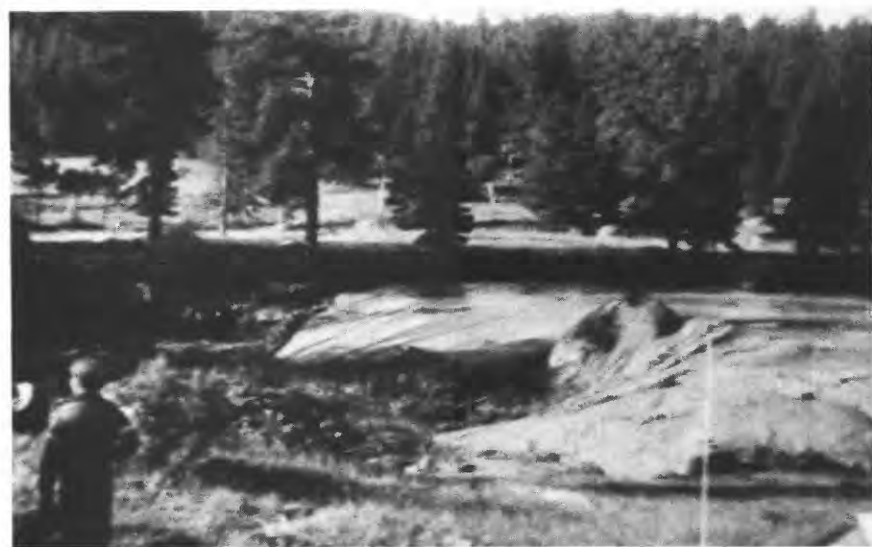
The Malpasset Dam was a high concrete-arch structure and Cascade Lake Dam was a concrete-gravity dam. These kinds of dams are more susceptible to rapid failure than most of the other types. The sequence of the toppling failure of Cascade Lake Dam, Colorado, is shown in figure 6. The inflow flood peak leading to the failure was 45 percent of the outflow peak following the failure.

Figure 6. Photographs showing sequence of Cascade Lake Dam failure, Colorado, July 15, 1982 (from Jarrett and Costa, 1985).

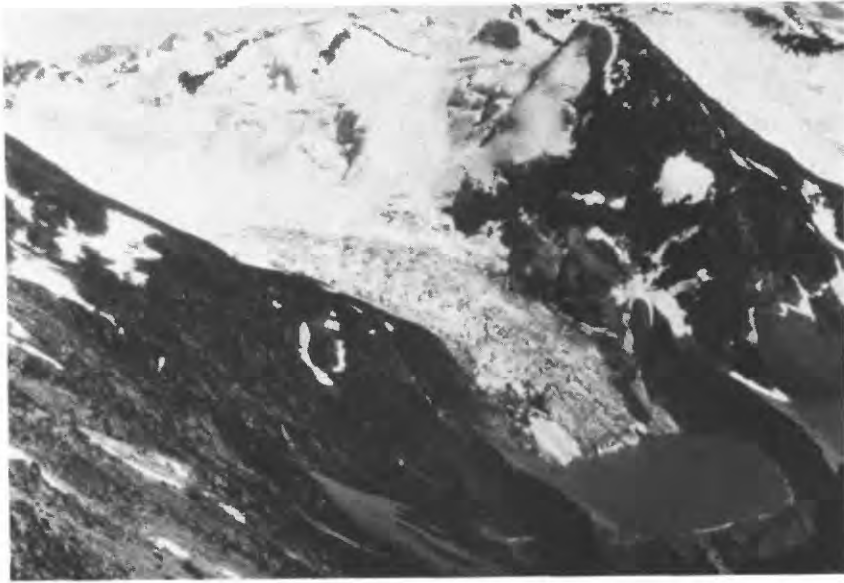
Figure 10. A. Aerial photograph of Nostetuko Lake and Cumberland Glacier, British Columbia, Canada, in July, 1977. (Photo by J. M. Ryder, courtesy of Michael Church).

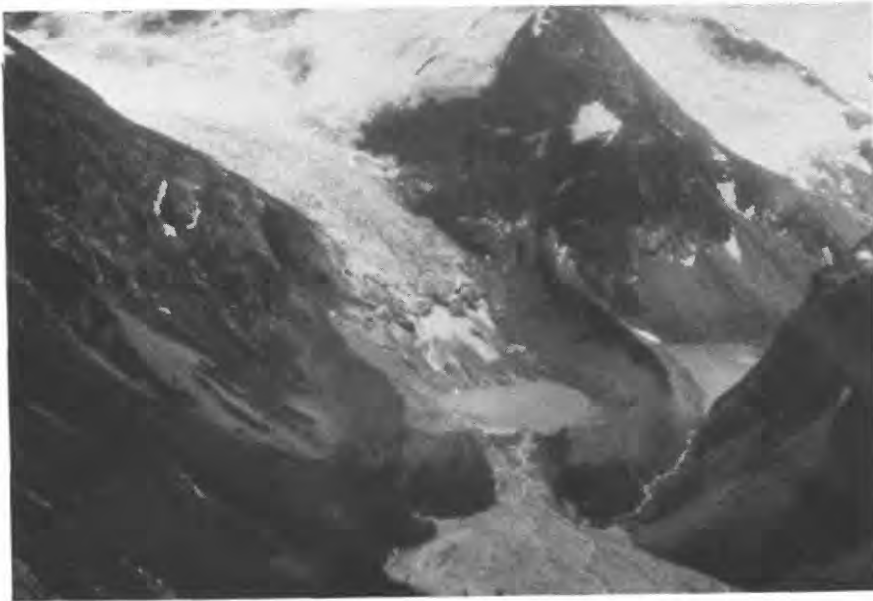
B. Aerial photograph of Nostetuko Lake and Cumberland Glacier, British Columbia, Canada, in August, 1983, after the morainal dam was breached. (Photo courtesy of Michael Church).

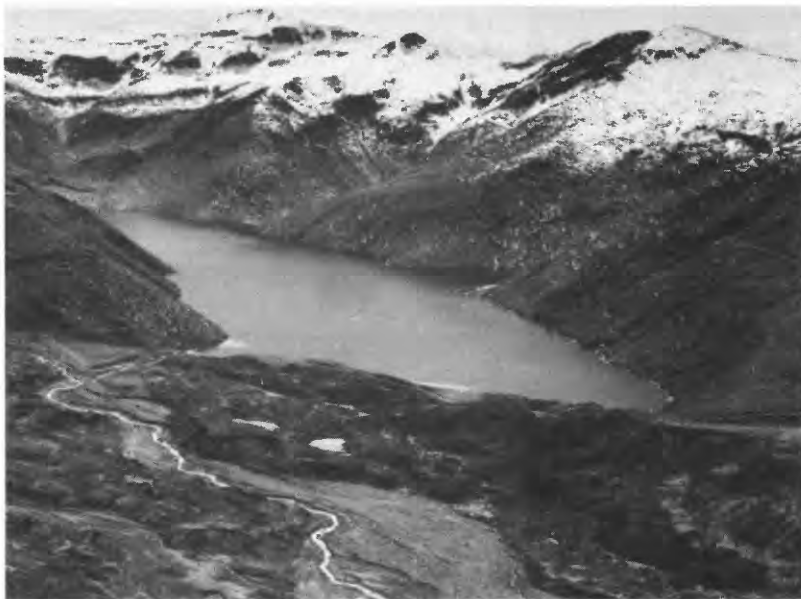
Figure 11. Photograph of Castle Lake, Mount St. Helens, Washington, dammed by a debris avalanche deposit. Debris avalanche moved from left to right in photo. An artificial spillway was cut into the right embankment. (April, 1984) (Photo courtesy of R. L. Schuster).

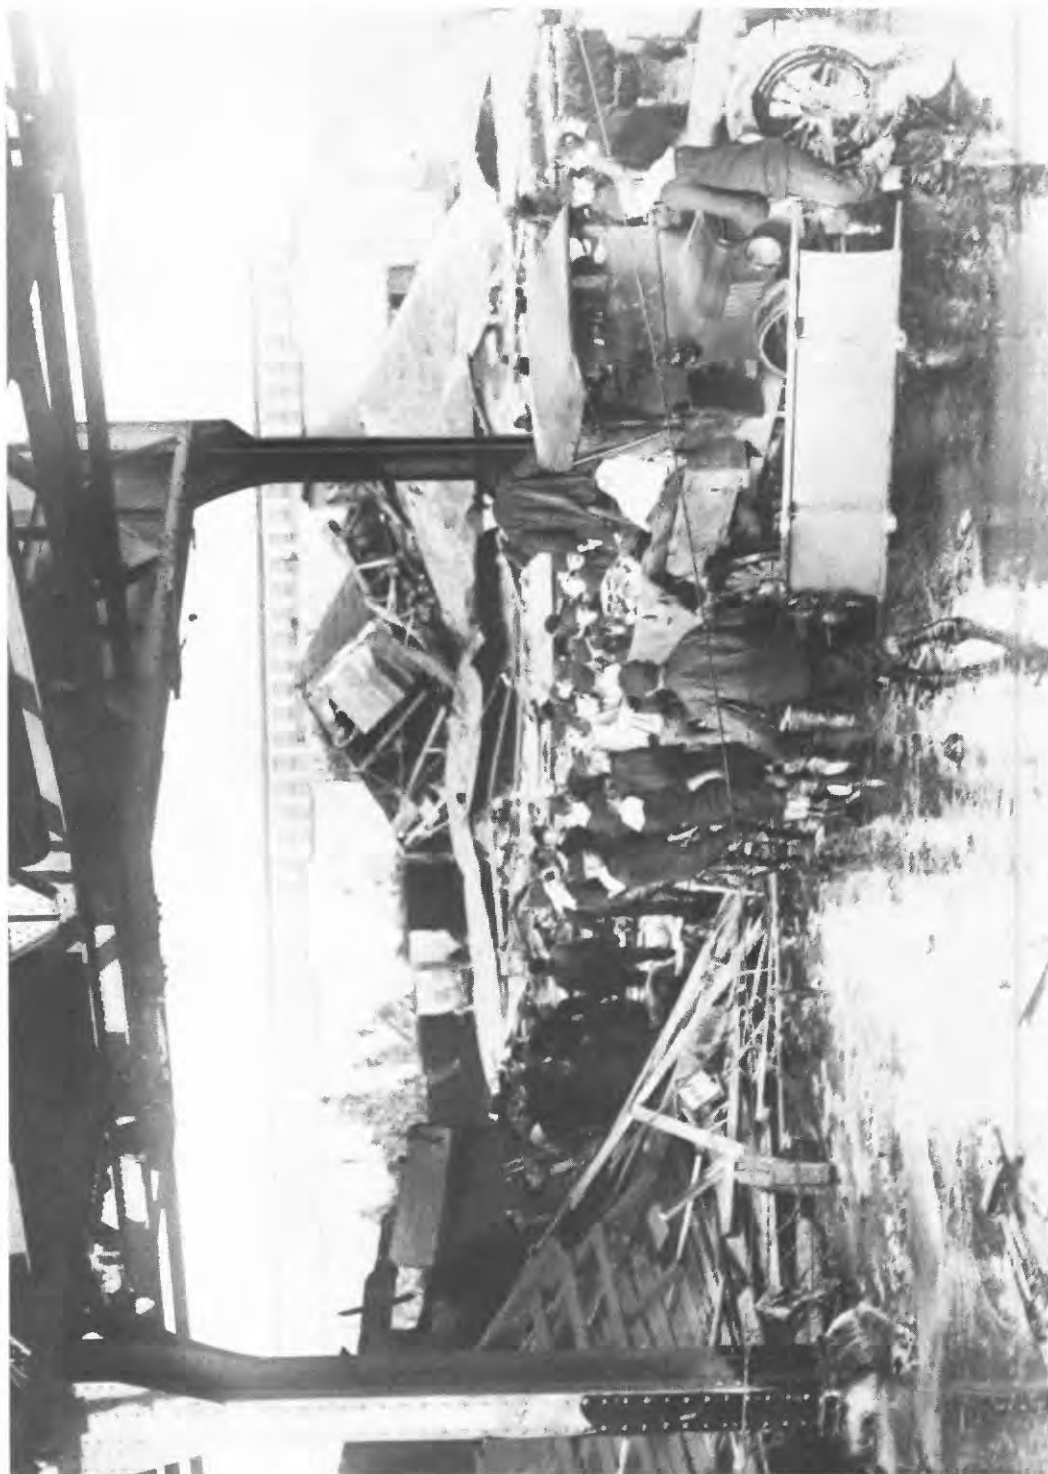
Figure 14. Damage from collapse of giant molasses tank at Boston harbor, January 15, 1919. View along Atlantic Avenue. Photo courtesy of the Boston Public Library, Print Department.
