Performance of steel structures during the 1994 Northridge earthquake

**Robert Tremblay, Peter Timler, Michel Bruneau, and
André Filiatrault**

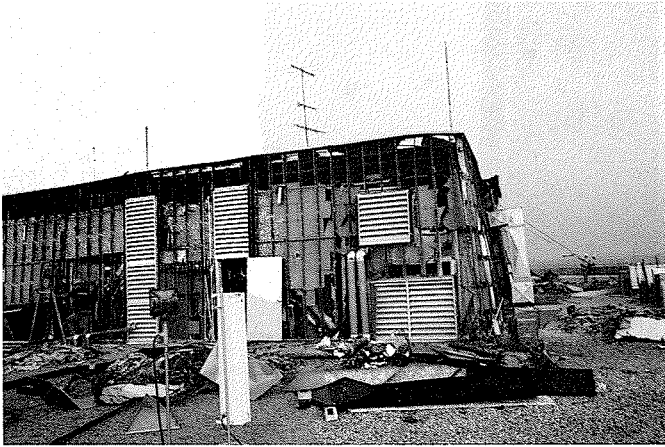
Fig. 1. Kaiser Permanente Hospital: cladding loss on penthouse.

This existing hospital was a ten-storey reinforced concrete building located only a few kilometres from the Northridge epicenter. The facility suffered significant mechanical (HVAC) losses due to severe damage to a steel framed penthouse. This mechanical room was constructed from a light structural steel frame with a cast-in-place concrete roof deck incorporating double angle chevron bracing. The penthouse was severely racked in the north-south direction displaying near complete cladding loss and extreme buckling (both in-plane and out-of-plane) of the bracing system (Figs. 1 and 2).

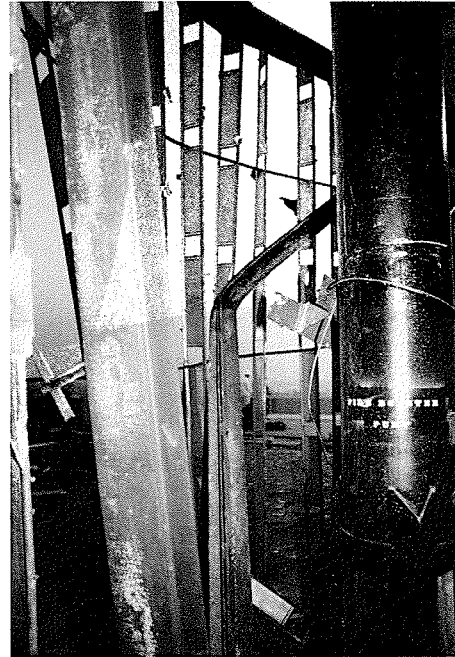
Fig. 2. Kaiser Permanente Hospital: buckled double angle chevron bracing in penthouse.

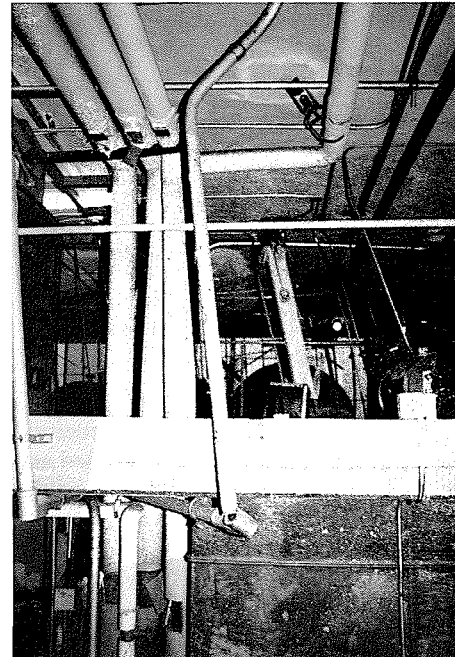
Since the electrical, plumbing, and ventilation were rigidly connected to both the roof soffit and walls, their associated systems suffered either damage or service loss resulting in the closure of the top three floors of the hospital until repairs could resume their functionality (Fig. 3). It is estimated that the hospital's capacity for patient care was reduced to approximately the 60% level as a result of mechanical penthouse failures.

Fig. 3. Kaiser Permanente Hospital: racking of services attached to penthouse roof.

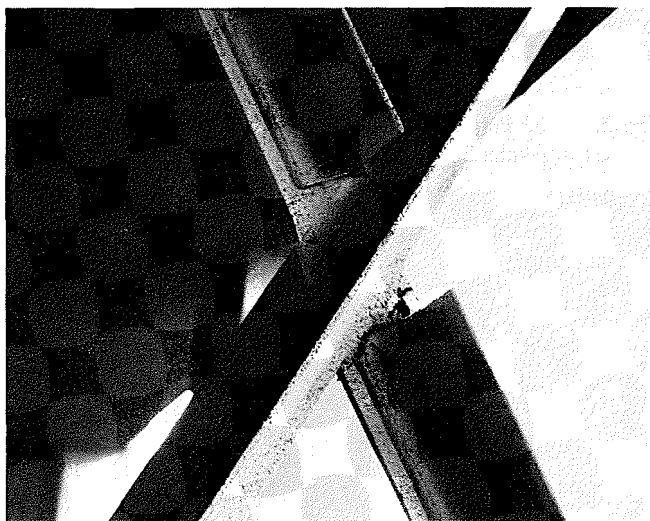
bracing members (Fig. 5). At the base of the columns of the X-braced bays, evidence of uplift could be observed, as the tiles on the ground and the stucco covering the columns were damaged (Fig. 6). This suggests that neither the anchorage nor the brace connecting plates could sustain the load that developed in the braces.

Fig. 5. First Interstate Bank Building in Northridge: buckling of connecting plate at brace intersection.

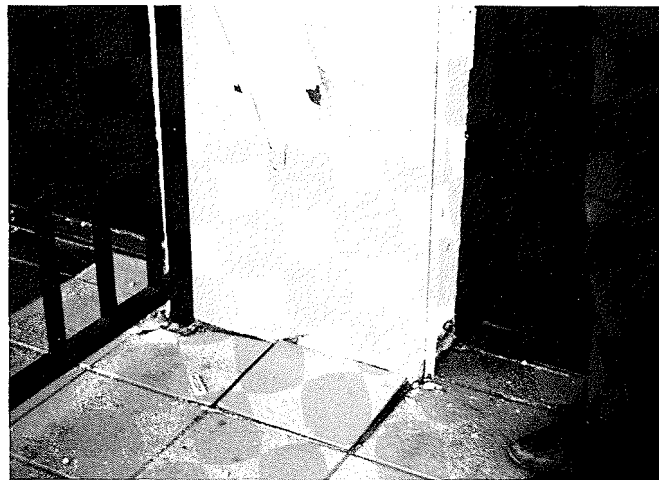
Fig. 6. First Interstate Bank Building in Northridge: column uplift at the base of the X-bracing.

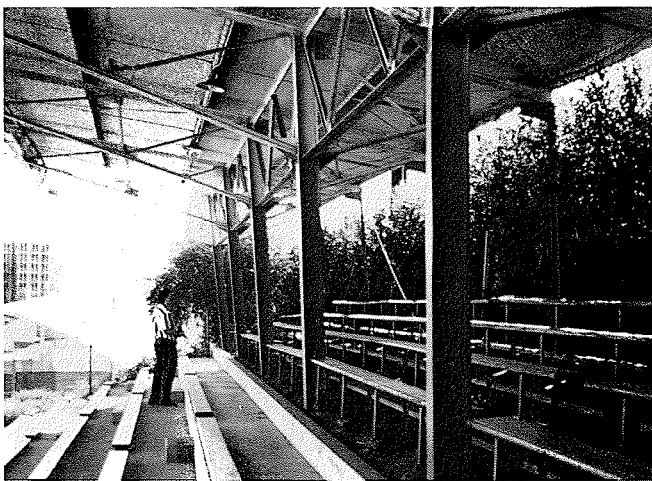
Fig. 9. Roof structure covering the bleachers of the football field at the California State University at Northridge: cantilevered steel frames.

The first four bays at the south end of the roof structure exhibited approximately a 5° inclination towards the bleachers (Fig. 9) as a result of the failure of the anchor bolts of the

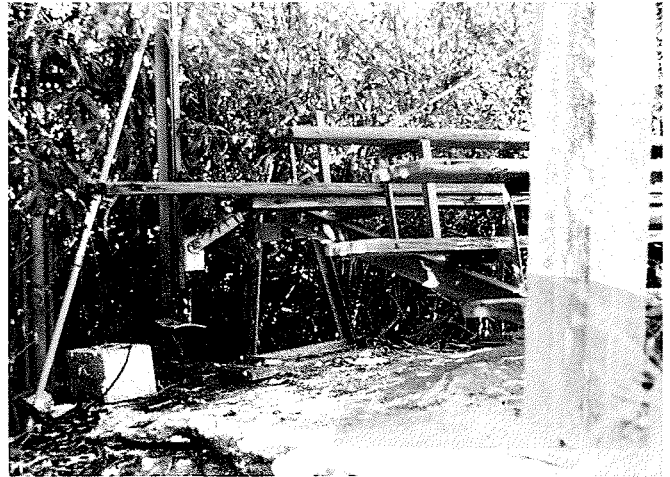
Fig. 10. Roof structure covering the bleachers of the football field at the California State University at Northridge: uplift of the back ties.

back ties during the earthquake (Fig. 10). Complete collapse of these four bays was inhibited only by the rotational restraint offered by the column base plate. The fact that anchor bolt failures occurred at the base of ties where longitudinal bracing diagonal members were attached as well as at the base of ties with no such diagonal members indicates that vertical accelerations undergone by the cantilevered roof likely contributed to the observed damage. According to the owner's representative, the structure has been dismantled after the earthquake and was to be replaced with a new one.

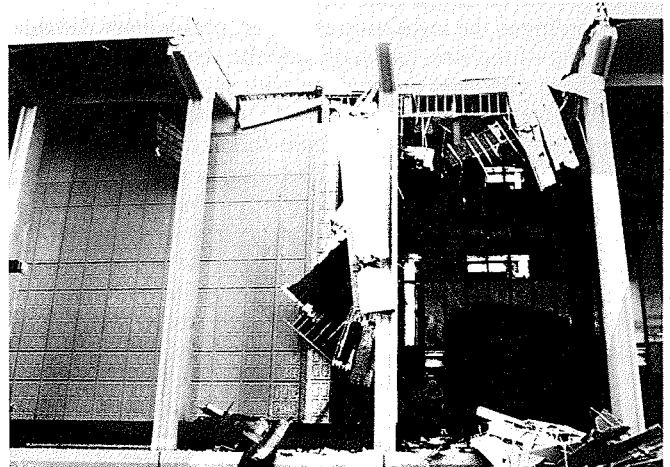
Fig. 11. Oviatt Library Building at the California State University at Northridge: failure of the overhanging roof.

This is a four-storey building including a concrete framed central part built in 1971. Two wings made of steel braced frames were added in 1991 at the east and west ends. The building had a steel framed overhanging roof along its perimeter. At two locations along the north wall, the steel beams of that projected roof running parallel to the exterior wall, and spanning across an expansion joint in the main framework, collapsed (Fig. 11). This failure has been attrib-

uted to the loss of bearing support of these beams and pounding damage due to the relative horizontal movement that took place at the expansion joints. No other structural damage could be noticed at the time of the visit.

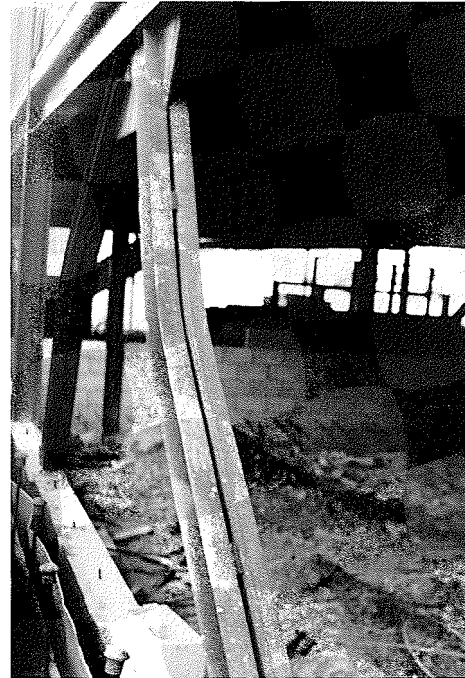
The structure did not suffer any significant damage, although the ground shaking was particularly strong in that area. However, all bracing members at the first floor experienced significant inelastic out-of-plane buckling (Fig. 13). As shown, both braces were permanently deformed in the

Fig. 13. Three-storey building under construction in Van Nuys: out-of-plane buckling of the first-storey bracing members on the north wall.

buckled shape, which indicates that both braces likely yielded in tension during the ground shaking. These members were made from back-to-back channels, 152 mm in depth and 76 mm in width, assembled by means of 10 mm spacers at quarter span. Though an unbalanced vertical force likely developed at the apex of the V at mid-span of the beams, no signs of plastic deformation could be observed along the beams (Fig. 14). The moment resisting frames in the north-south direction did not suffer any visible damage.

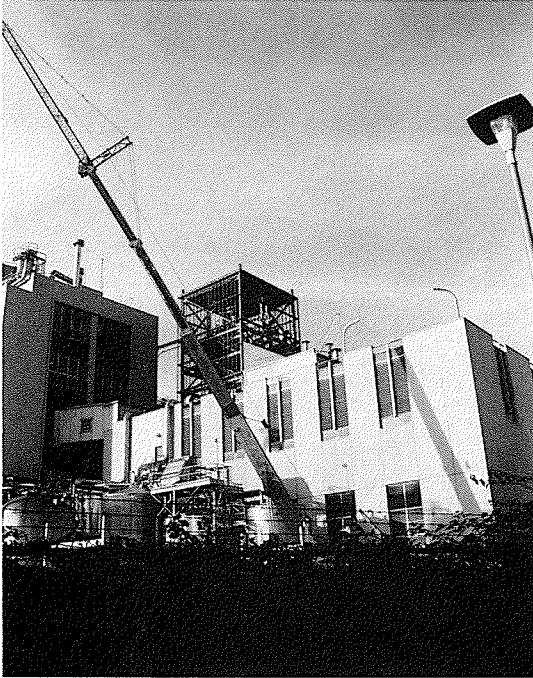
Fig. 15. No. 2 Brewhouse, Anheuser-Busch, Inc.: cladding failure on tower structure.

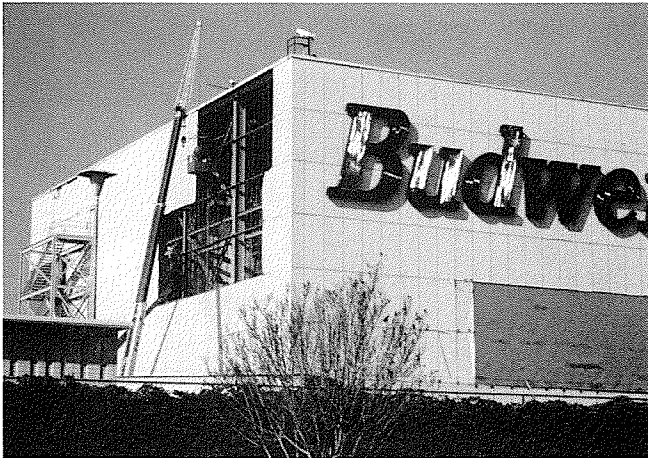
Fig. 16. No. 2 Brewhouse, Anheuser-Busch, Inc.: global view of cladding failure on warehouse.

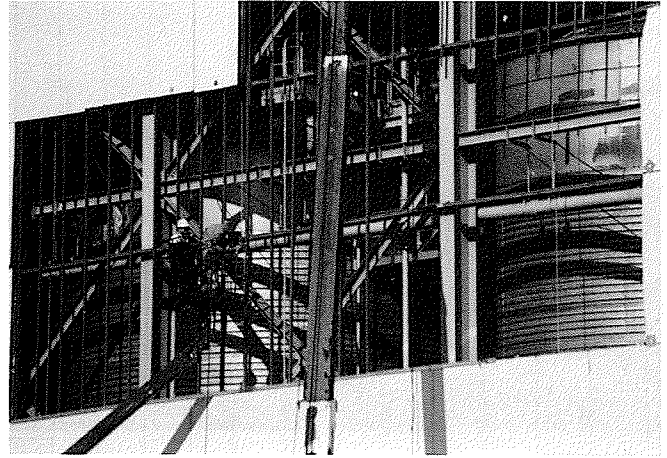
Fig. 17. No. 2 Brewhouse, Anheuser-Busch, Inc.: close-up view of cladding failure on warehouse revealing steel braced frame.

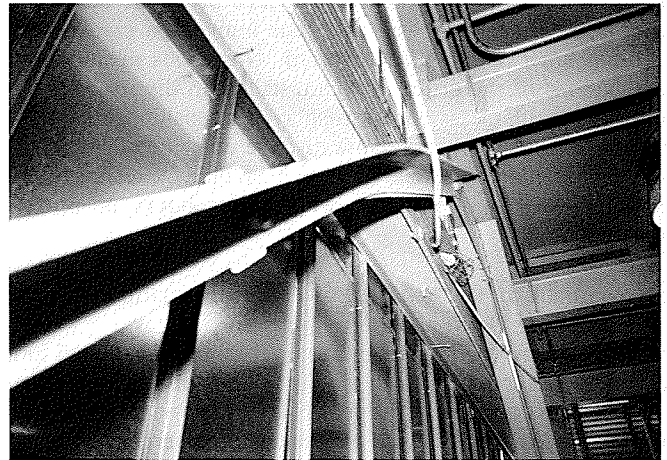
ridge epicenter. Significant shaking at the plant was experienced by personnel during the main shock and aftershocks. The No. 2 Brewhouse is a four-storey concentrically braced structure incorporating wide flange shapes as bracing members. An additional five-storey mechanical tower structure was located on the east end of the brewhouse roof. Significant cladding loss and damage occurred on the tower section of the brewhouse, and other warehouse structures located at the plant experienced similar problems (Figs. 15–17). In addition to the cladding failure, several double angle chevron bracing in the tower portion had buckled (Fig. 18).

Fig. 18. No. 2 Brewhouse, Anheuser-Busch, Inc.: buckling of double angle chevron bracing in the tower portion.

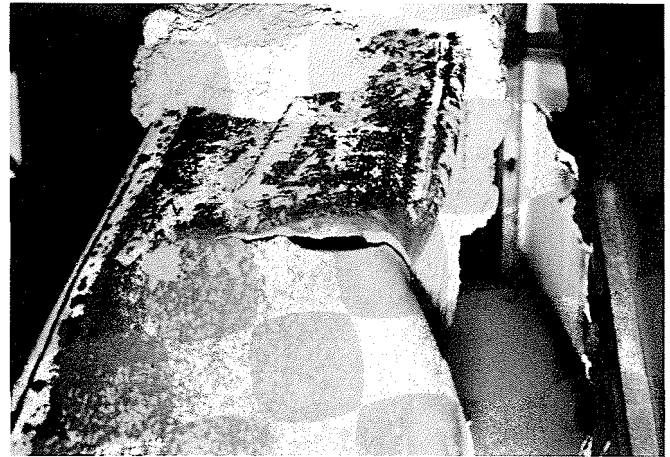
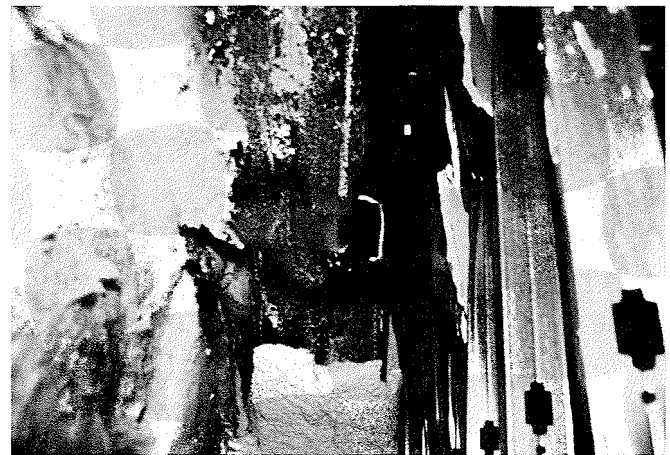
Fig. 24. Four-storey commercial office structure: local failure of hollow structural brace at center.

failures. Most of the severe damage was limited to the north-south oriented braced bays at the second floor. This potentially implies that the demand-to-capacity ratio of the braces was somewhat higher at the second floor (Bonneville 1994) and that the existing chevron braced system was not capable of redistributing forces to other levels after the second-storey failures occurred. Significant ductility problems were exhibited in the HSS 305 × 305 × 9.5 mm (12 × 12 × 3/8 in.) tubular braces. Many of the failures found were attributed to local plate instability of the section because of the high width-to-thickness ratios of the walls of the steel tubes. Local buckling was isolated either the end connection or the center of the brace (Figs. 23 and 24). Ruptures in the braces were caused by high stress, low cycle fatigue resulting in the formation of a brittle crack at crimped wall failures from local instability. One brace had ruptured completely through its cross section (Fig. 25).

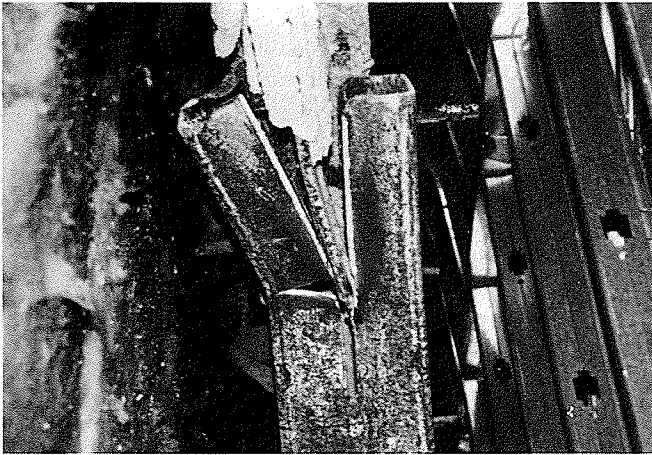
One braced frame failed at its slotted welded connection to the gusset (Fig. 26). At another location within the structure, where the bracing was discontinuous or offset and a special moment connection was required, the resulting

Fig. 26. Four-storey commercial office structure: failure at slotted gusset connection.

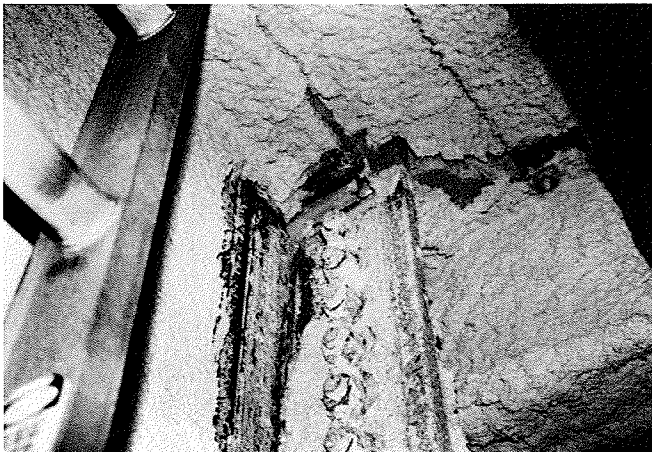
deformations initiated the fracture of a full penetration weld connecting the girder to column flange (Fig. 27). Intense out-of-plane buckling of the braces initiated precast facia panel damage. Even for this extreme loading condition, however, the panels performed well and none became detached from the structure. There was also some permanent deformation in girders from in-plane bending due to frame behavior and torsion due to brace buckling during the earthquake.

Fig. 27. Four-storey commercial office structure: fracture of full penetration weld at girder flange.

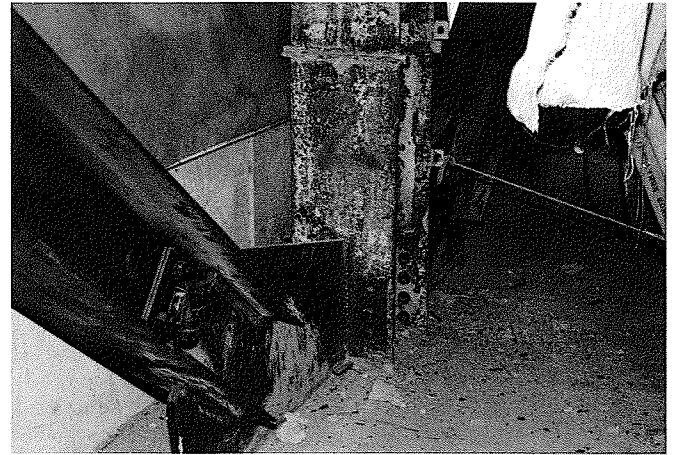
Fig. 28. Four-storey commercial office structure: newly installed wide flange braces and gussets.

bents during future earthquakes. Such seismic structural behavior would have been far less desirable than the actual performance during the Northridge earthquake. Thus, all braces throughout this building were replaced by new 350 mm deep wide flange members (Fig. 28). These elements have a global buckling strength close to that of the original members but meet all the seismic design ductile detailing requirements specified for special concentric braced frames in the U.S. (e.g., AISC 1992). These requirements are essentially identical to those for ductile braced frames in the S16.1 Canadian standard. Attention has also been devoted to brace connections. The sizeable gusset plates, typically designed to be stronger than the brace members in special concentric braced frames, are noteworthy (Figs. 28 and 29).

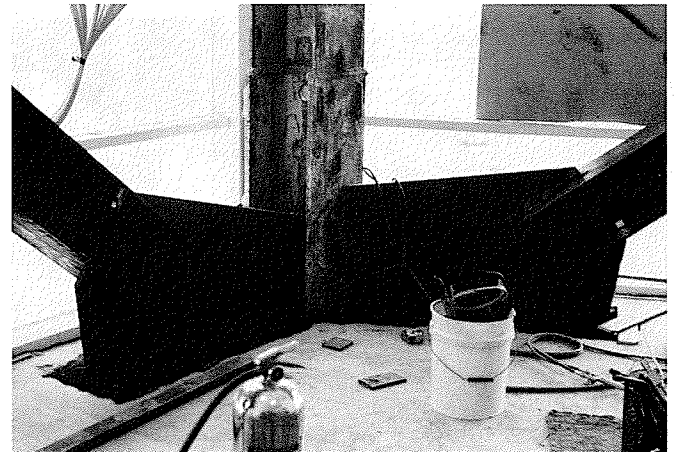
Fig. 29. Four-storey commercial office structure: close-up view of new gussets at brace end for corner columns.

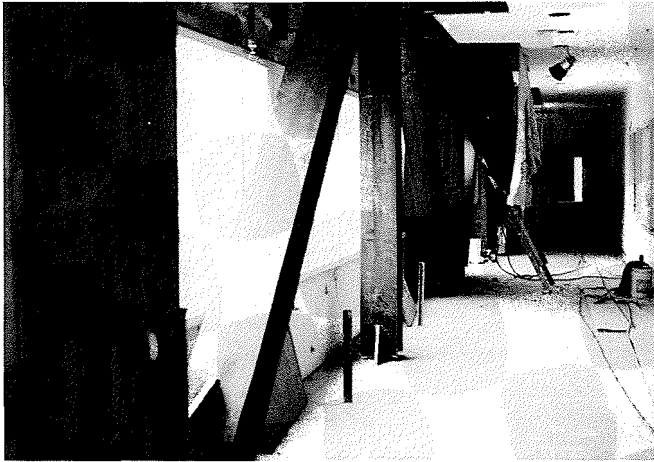
Fig. 30. Four-storey commercial office structure: newly installed braces in repaired inverted chevron-type braced-frame with vertical tie-members added to implement “zipper” system.

In order to better distribute the ductile behavior to all stories of the building, vertical members were added to tie all chevron braces together over the height of this building (Fig. 30). As such, to the authors' knowledge, this represents the first implementation of the "zipper" system developed a few years ago by Khatib et al. (1988) to remedy the deficiency germane to chevron braced frames that have a tendency to concentrate seismically induced inelastic response

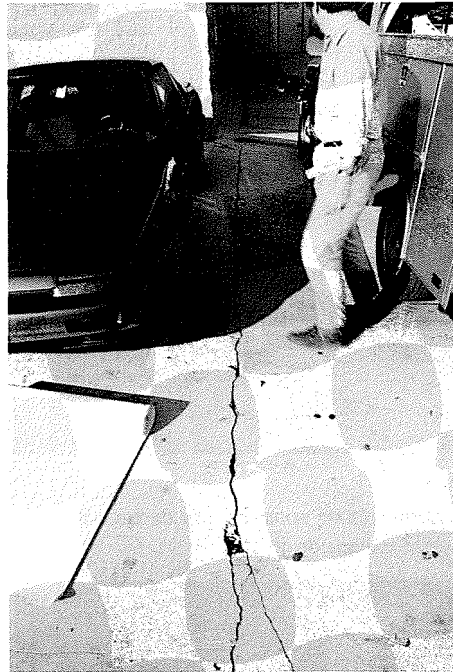
Damage observed at this structure included longitudinal cracking in the concrete slab cast on light gauge steel decking likely related to diaphragm action. This was particularly evident in the rear parking area at street level along the beam lines (Fig. 31), but was also witnessed at the second floor level of the plaza. Tension and shear failures of two corbels supporting beams were also discovered in the lower parking level (Fig. 32). Nominal overall member buckling had occurred in an exposed wide flange brace at the rear of the structure (Fig. 33).

Fig. 31. Two-storey fashion plaza: cracking along beam lines in parking deck.

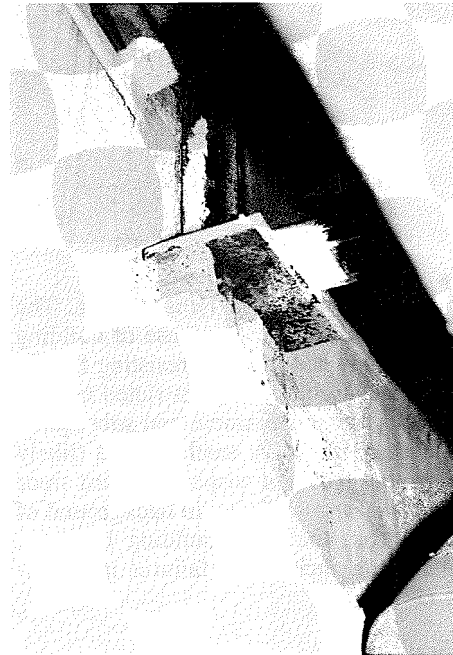
Fig. 32. Two-storey fashion plaza: beam anchorage failure at corbel.

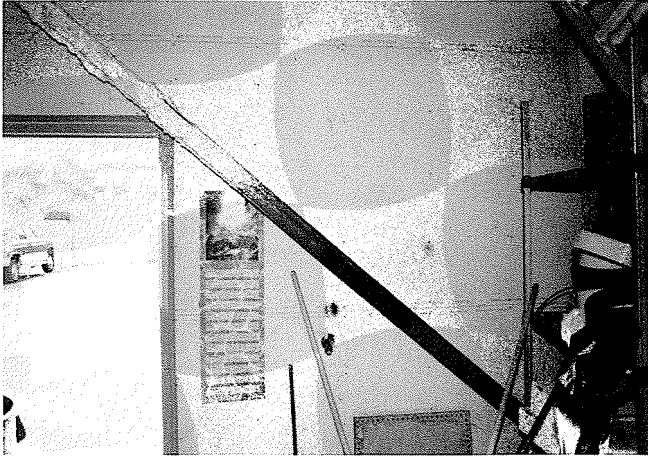
Fig. 33. Two-storey fashion plaza: slight overall member buckling of wide flange brace.

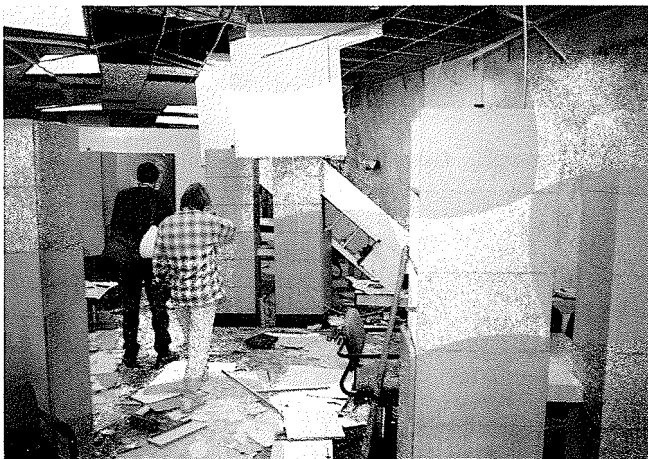
Very little nonstructural damage and chaos occurred in the merchant area braced with the tubular chevron bracing albeit these areas were void of suspended ceiling and other architectural finishes, whereas severe nonstructural damage occurred in the moment resisting framed areas of the structure

Fig. 34. Two-storey fashion plaza: nonstructural damage in moment framed areas near expansion joints.

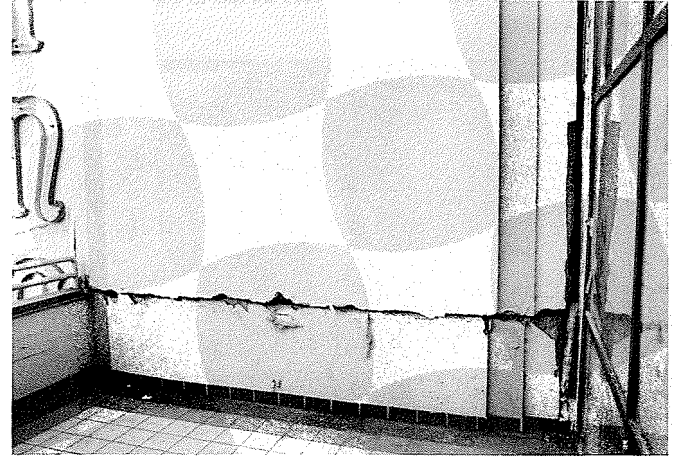
although the frames did not exhibit any damage themselves from initial observations (Fig. 34). At the former theater section, a steel framed sign structure suffered bolt shear failures at the column splice locations at the second floor, necessitating its subsequent removal for hazards mitigations (Fig. 35).

Fig. 35. Two-storey fashion plaza: sign frame anchorage shear failure in the former theater portion.

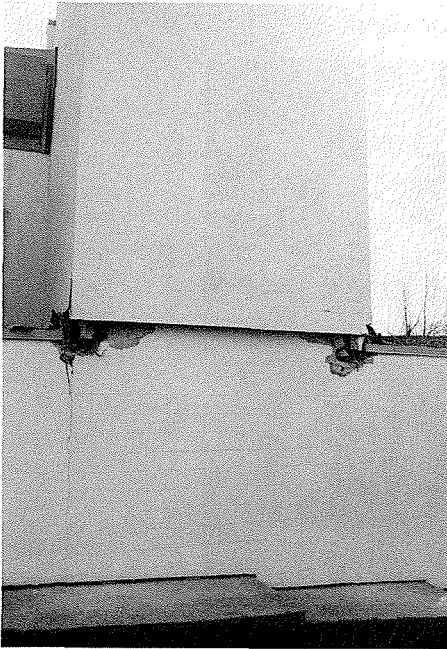
framed building located in the Mission Hills district. The street bracing system was not identified because of building finish cover but possibly contained moment resisting frames in some areas. Entry to the structure was restricted to only record retrieval following initial assessment and subsequent decision for its future demolition. A steel framed (likely diagonally braced) elevator shaft and suspended third floor walkway (behind stair tower and walkway in background of Fig. 36) had separated from the main building by some 200–250 mm due to column anchor bolt failures in a reinforced masonry wall (Fig. 37).

Fig. 37. Holy Cross Hospital administration building: elevator shaft column anchorage failure.

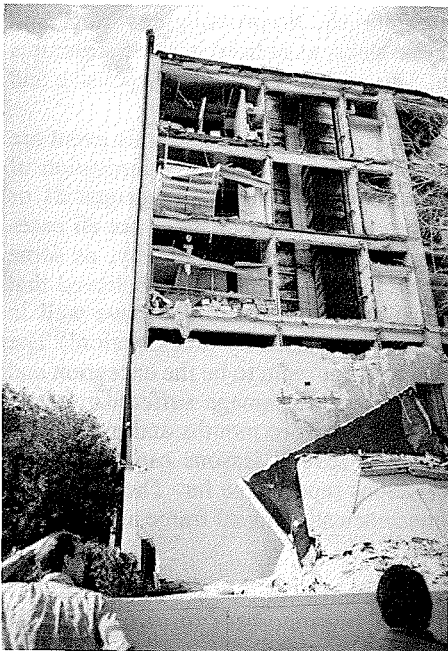
A five-storey office structure located in the Van Nuys district suffered significant damage. Concrete-encased steel moment resisting frames for the north–south and east–west orientations of the building layout provided the lateral load resisting system. The building was essentially plumb following the earthquake; however, facade failures were apparent, most obvious at the east and west end walls of the structure (Fig. 38). The east end wall was constructed of a double

The separation of both the end wall and stair tower is attributed to dowel shear failure between the floor slabs and the end facade walls. The end wall's collapse mechanism is surmised to have been initiated by shear failure at the base followed by bearing loss, allowing the remaining wall to vertically shear and slide down the face of the structure. Concrete spalling was apparent at the top flange-slab locations as well as in the beam-column joint regions. Physical separation of the aluminum and glass south curtain wall was evident at the second floor level.

Fig. 38. Van Nuys office building: end wall failure on east face of building.

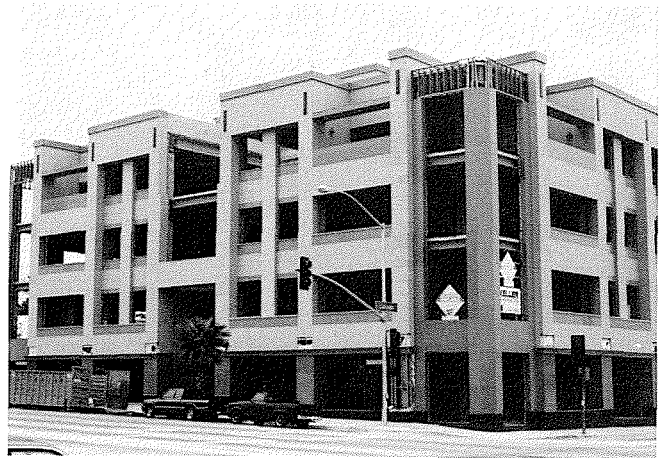
elsewhere, the contractor decided to randomly inspect a few beam-column connections by removing the fireproofing installed prior to the earthquake. Nearly all joints of the moment resisting frames located on the north side of the building were found to have severe fractures.

Fig. 39. Moment resisting frame under construction: north facade along which beam-column connections suffered cracking and fractures.

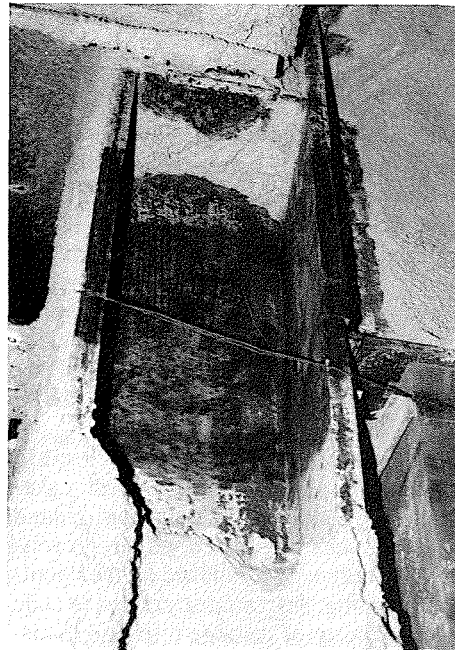
Fig. 40. Moment resisting frame under construction: typical beam-column connection damaged by column cracking and fracture at the level of the beam's lower flange weld.

the beam's lower flange, and cracking propagated into the column's web a short distance horizontally, then mostly vertically and toward the other flange weld of the same beam.

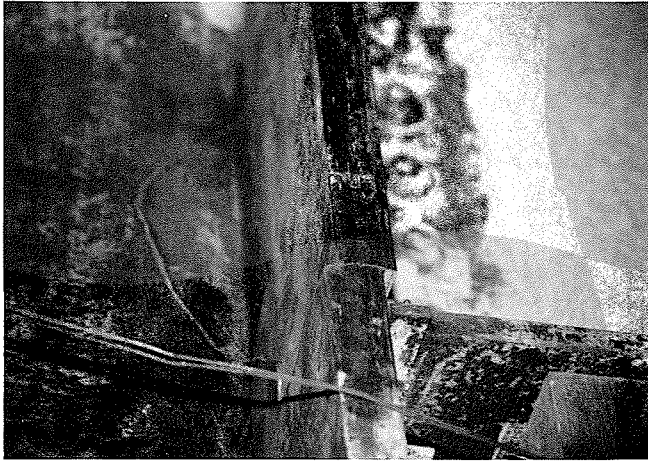
Fig. 41. Moment resisting frame under construction: close-up view of the fractured column shown in Fig. 40.

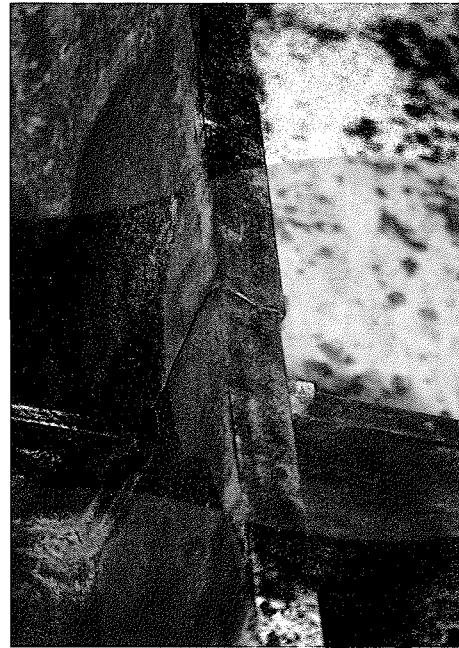
Fig. 42. Moment resisting frame under construction: close-up view of a beam-column connection damaged by column flange fracture at the level of the column web stiffener (left) and beam's lower flange (right).
