Damage from the Great East Japan Earthquake and Tsunami - A quick report

Keywords Great East Japan Earthquake and Tsunami · Damage · Tsunami prevention measures · Nuclear power plant accident · Recovery and reconstruction

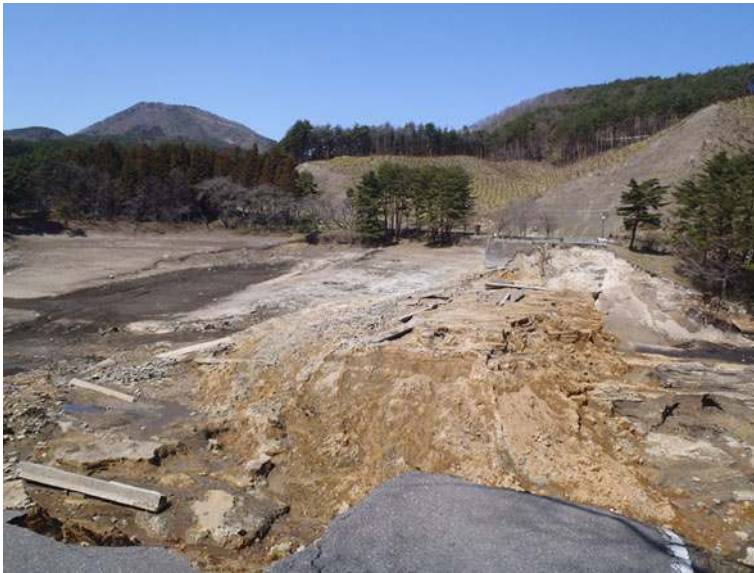
As a result of such motions, many impacts occurred on artificially reclaimed lands, soft alluvial plains, and fragile slopes. These are common land features in Japan. Land slides also created strong damage, because the sediment mass has large weight, and hence apply stronger impulse forces to buildings and other features. For example, in Sukagawa-city, Fukushima Prefecture, a 18.1 m high earth dam was broken, causing eight deaths and missing people (Fig. 4). Another landslide and debris flow occurred in Shirakawa-city and Nasukarasuyama-city killing 13 people, and with two people still missing.

Fig. 4 Burst dam (Fujinuma reservoir)

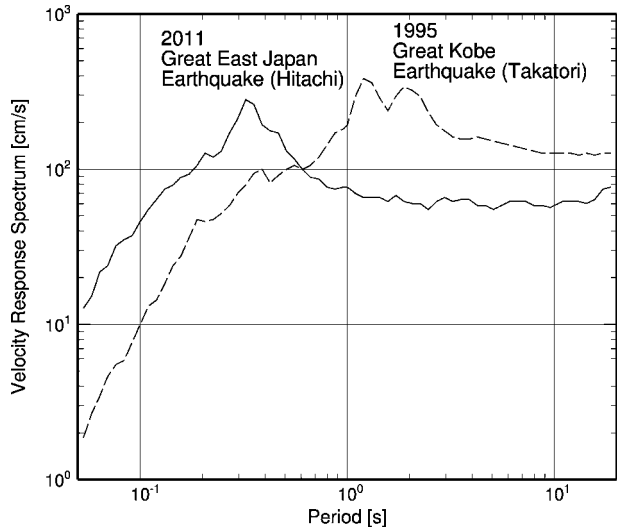
Building damage is closely related to the frequency responses. The frequency of the ground motion is higher than that of 1995 Great Kobe Earthquake, as shown in Fig. 5. This results in smaller effects on the structure of buildings. Therefore, the destroyed houses and buildings in the coastal areas were mainly due to the tsunami. However, in Ibaraki Prefecture, at the southern end of the damaged region, there were completely or half collapsed houses in inland areas. They were not damaged by the tsunami, but by the earthquake and resulting foundation failure.

Fig. 5 Frequency characteristics of velocity response spectrum (Revised from Earthquake Research Institute (2011))

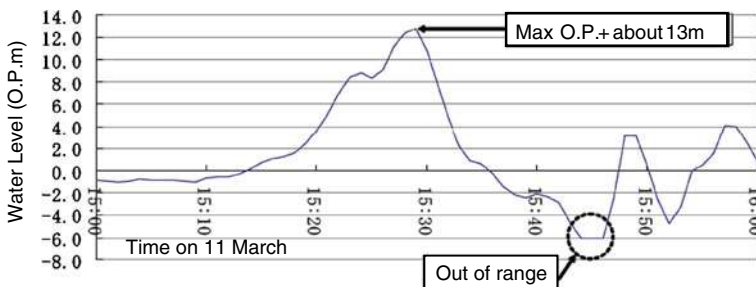
Fig. 7 Tsunami wave profile observed at Onagawa coast, Miyagi Prefecture. Note: O.P. is the datum at Onahama Port, Fukushima Prefecture. (Revised from Tohoku Electric Power Co. (2011))

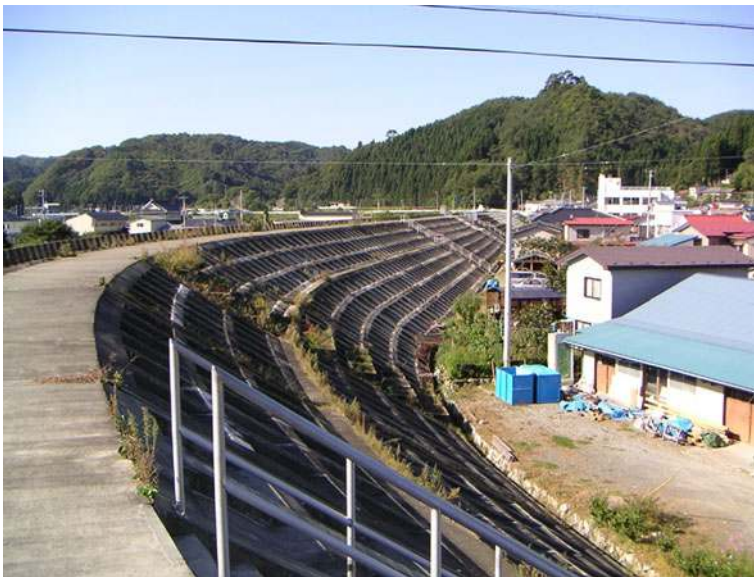
Taro district, in Miyako City, was surrounded by high coastal dykes called “Great Walls”. They were 10 m high and 10 km in total length (Fig. 8). Taro experienced a tragedy after being hit by a 10 m tsunami which killed over 900 people in 1933. They started to build the coastal dykes the following year. In 1958 a 10 m dyke system with a length of 1.4 km was completed. It worked very well in the occasion of the Chilean Tsunami in 1960, with no casualties. In 1979 the dyke system was partially upgraded to a great wall with a two-track structure. After that it continued to be effective.

The recent Great East Japan Tsunami flew over these structures, attacking cities and causing huge casualties. The bay-mouth breakwaters were destroyed in Kamaishi and Ofunato. The great coastal dykes in Taro could not prevent overflows and were destroyed as well. Some people claimed that the structures had no effect, and that disaster prevention education should be more effective. However, evidence from videos, photos and witnesses confirms that the coastal structures reduced the damage to some extent. Thus the role of coastal structures remains a controversial issue. However, it is true that the structures played a preventive role against past tsunamis which had heights lower than their design heights. Therefore, the role and effectiveness of structures when the tsunami is higher than the design criterion is a matter for further study.

Fig. 8 Ten meter high coastal dykes in Taro, Miyako City (Before the tsunami; Ministry of Land, Infrastructure, Transport and Tourism)

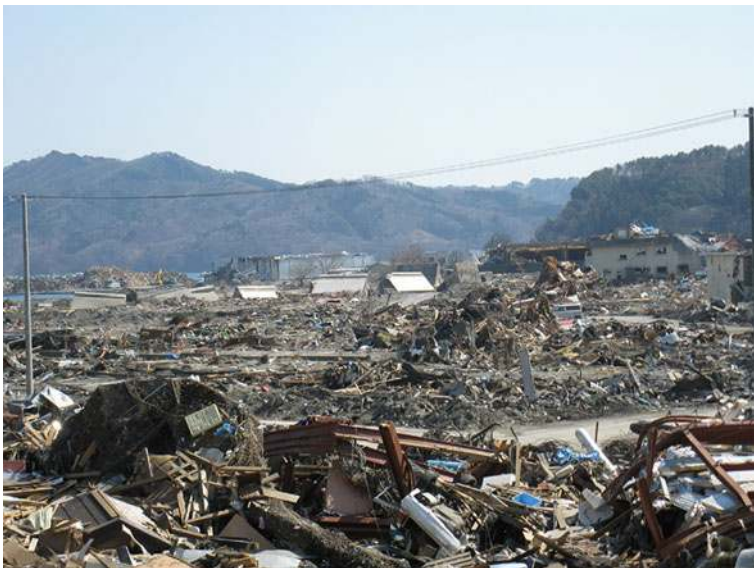
Fig. 9 Damages in Otsuchi (Photo: So Kazama, 5th April)
