First results of an aging test of a full scale MWPC prototype for the LHCb muon system

LHCb Muon Collaboration

Vsevolod Souvorov, CERN/PNPI

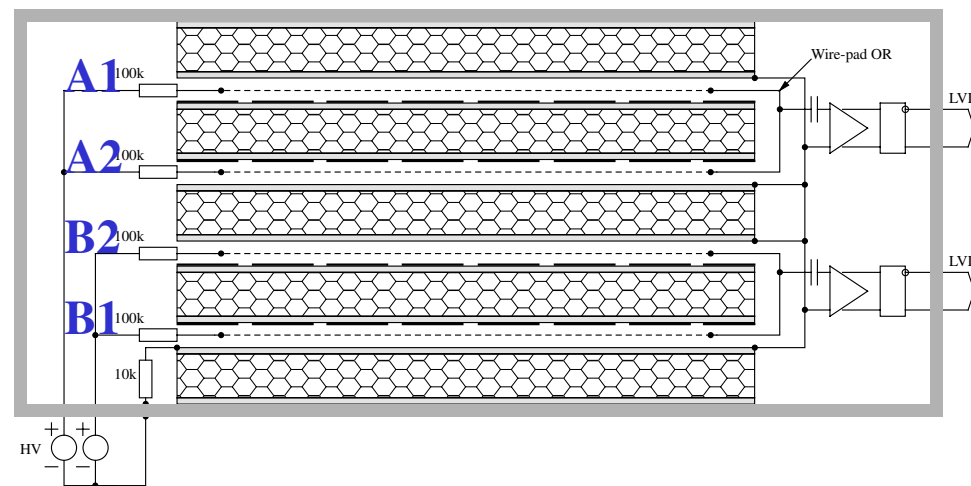
Chamber cross-section with the four gaps.

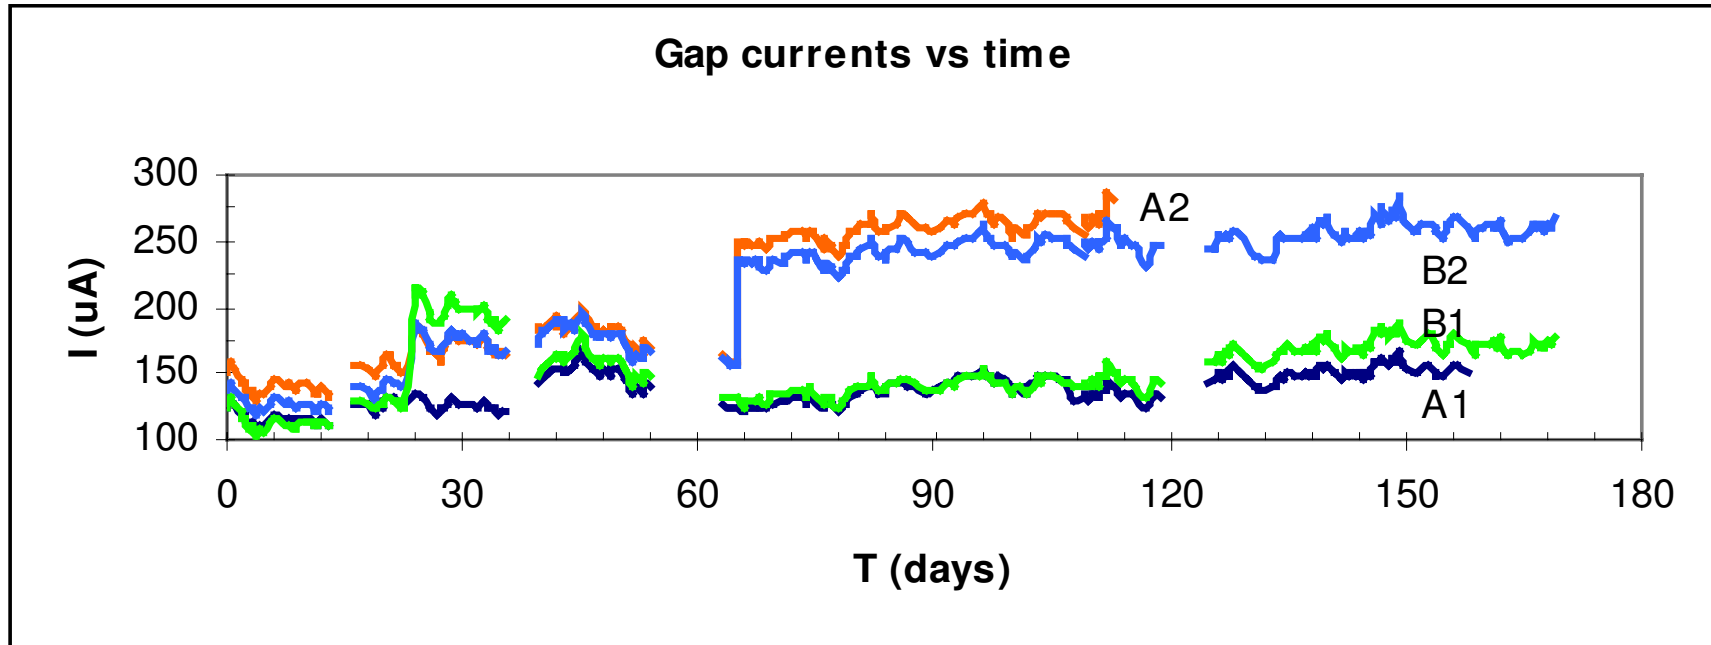
Gap currents vs time

The linear current density is less than 0.03 µA/cm.

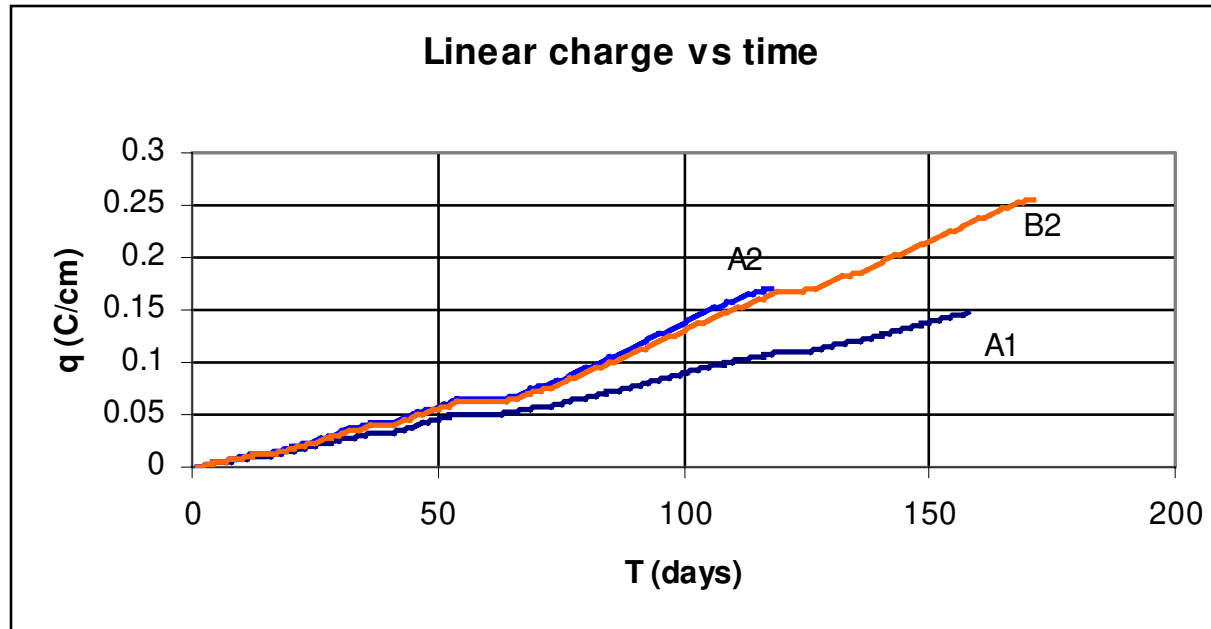
7.2.01:   The test starts

4.6.01:   Broken wire in gap A2.

The de/ef step is related with the spontaneous change of the B1 gain at the point e. The reason is the too large flexibility of the outer panel of gap B1.

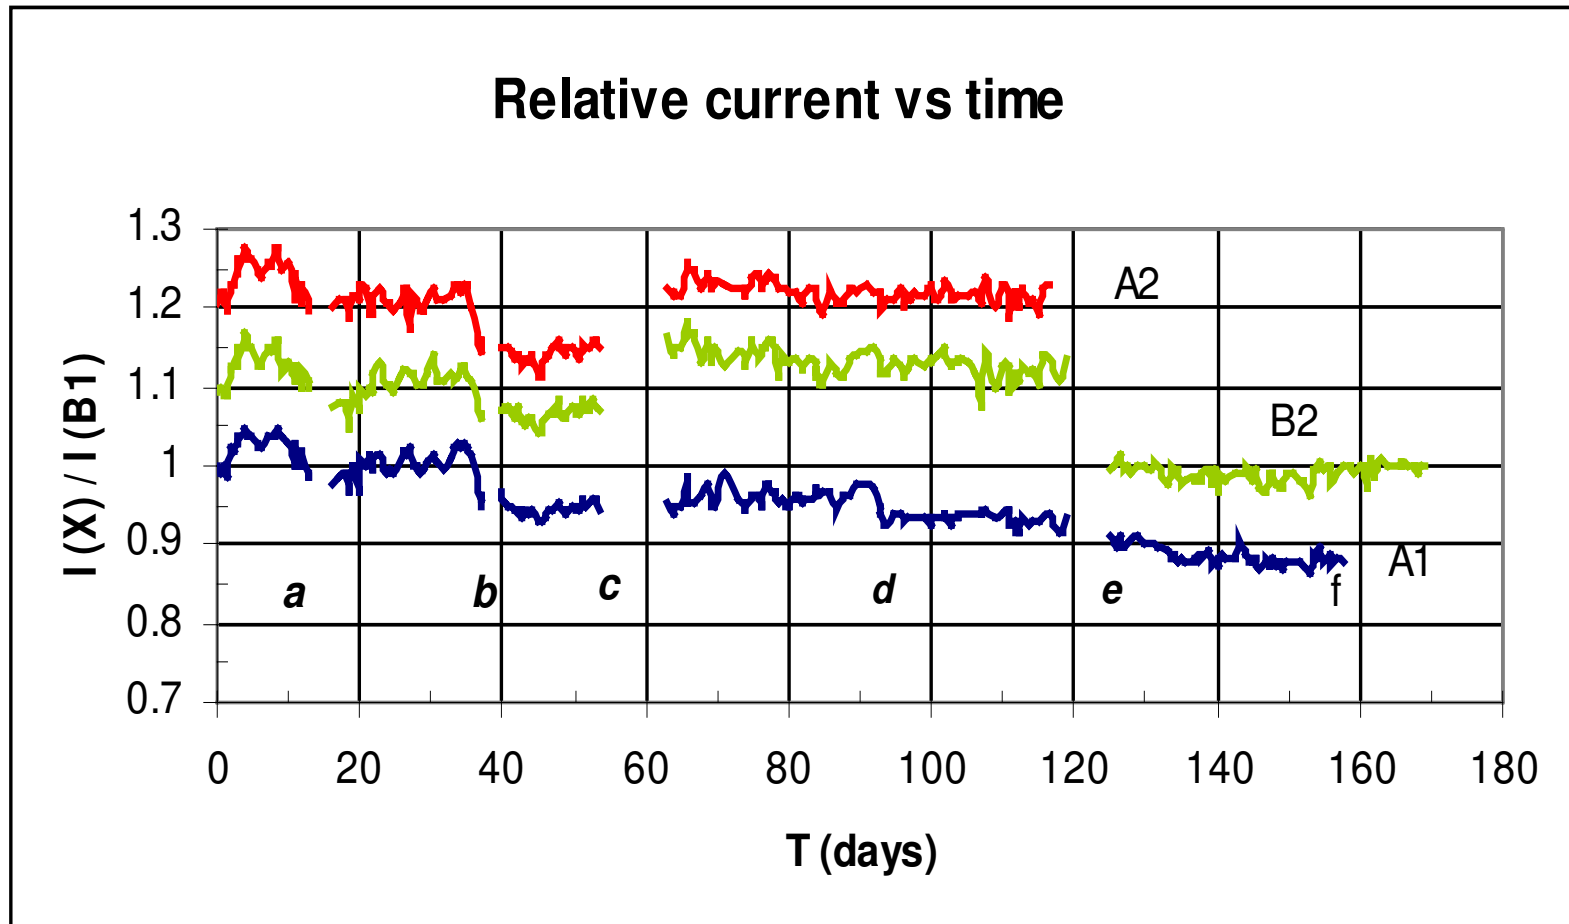
16.7.01: Gap A1 turned off due to HV trip.

27.7.01: End of test. Chamber opened for investigation.

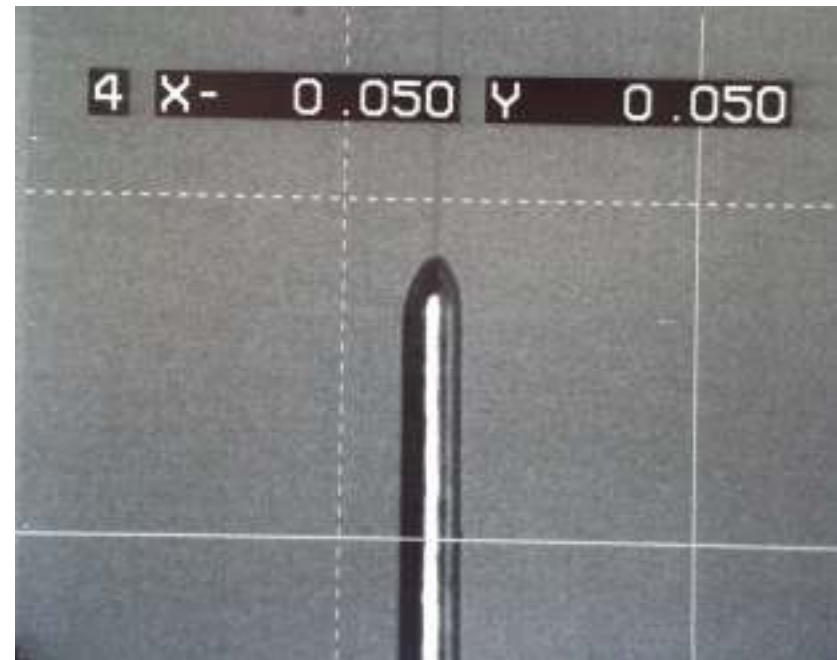
Anode Wire Investigations after the Test

- Anode wires stayed fairly clean.

- There is some minor deposit (black dots) sporadically scattered near two brownish spots on the cathodes. The amount of the spoiled wire surface is negligible ($<10^{-3}$).

- One wire broke (out of 2400). The reasons are not clear.

5.The breakdown of one wire and the HV instability of the A1 gap is a clear indication that the HV operational conditions should be optimized (HV could be reduced by increasing the Ar content of the gas mixture).

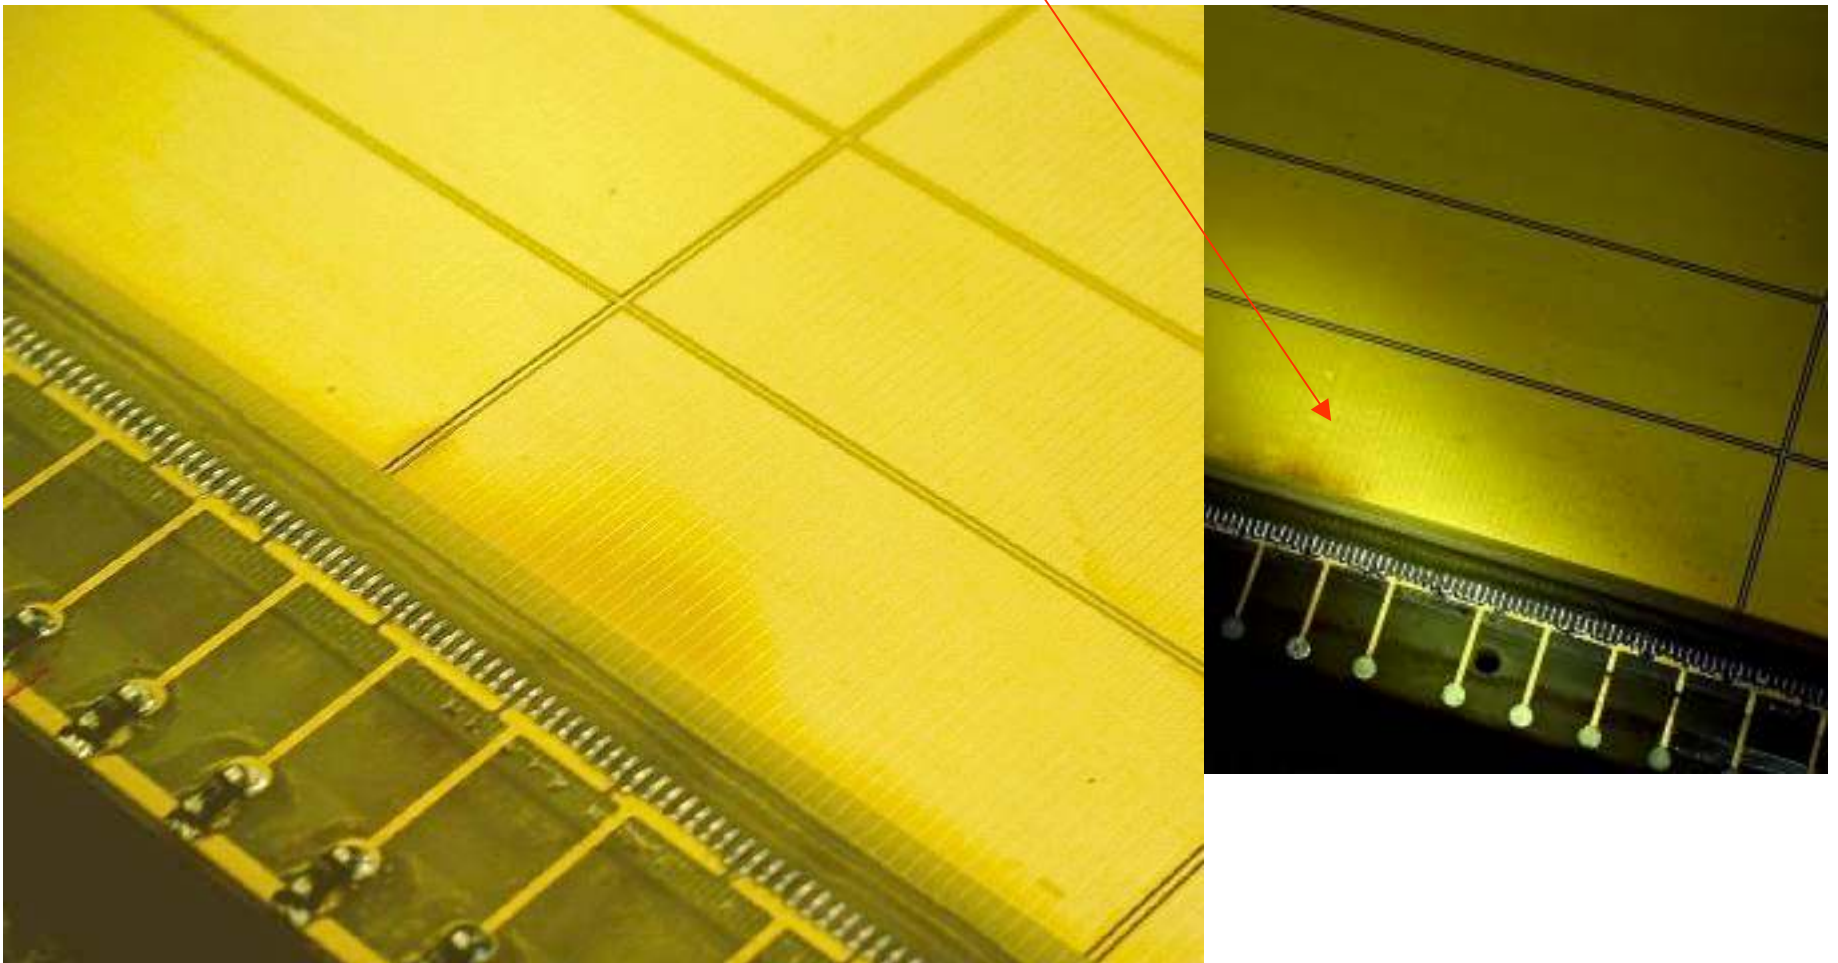
Gap A1: The brownish region near the wire fixation bar is a result of HV instabilities of the wire plane. A similar spot has been observed in gap A2 near the wire fixation bar where the wire was broken.

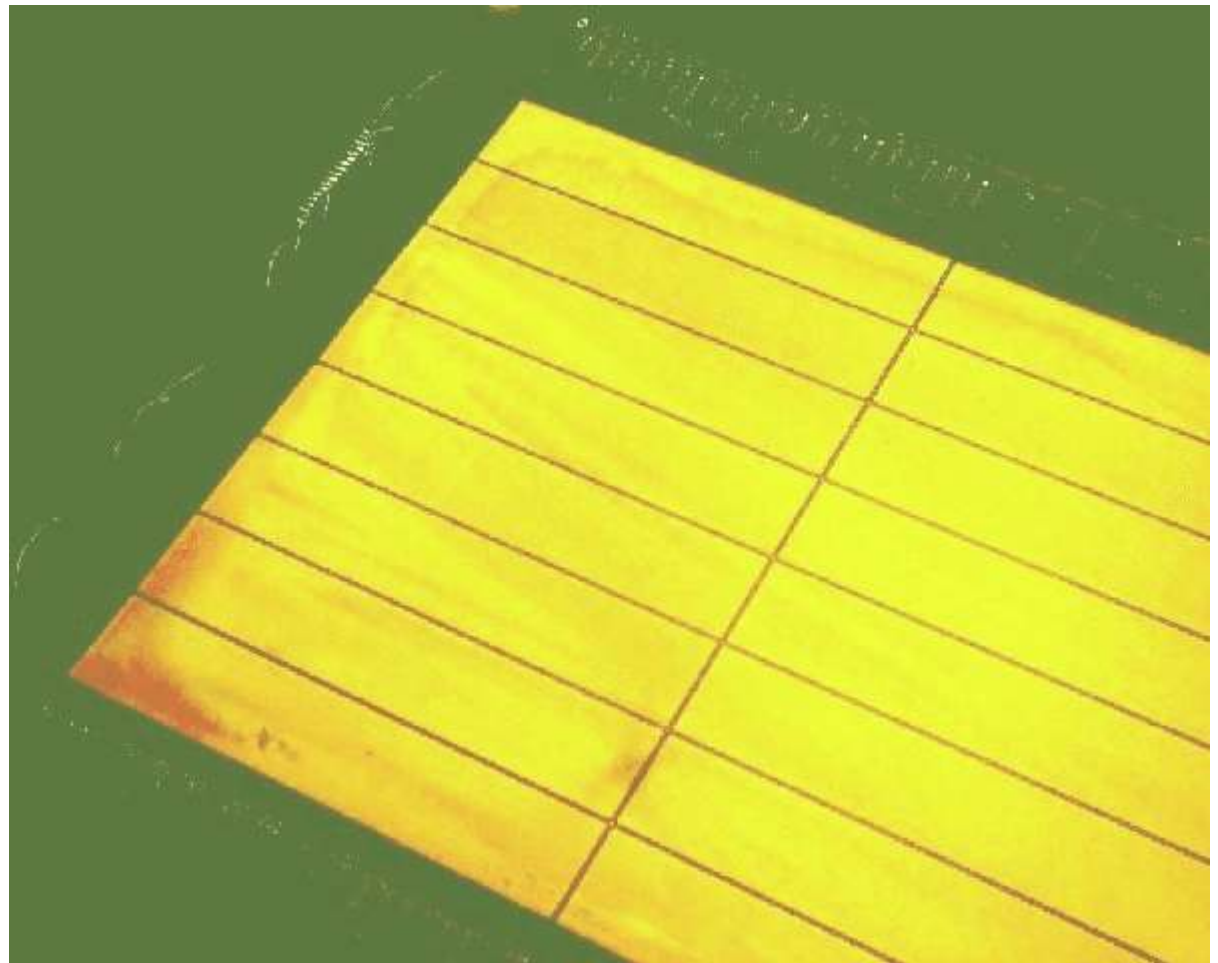
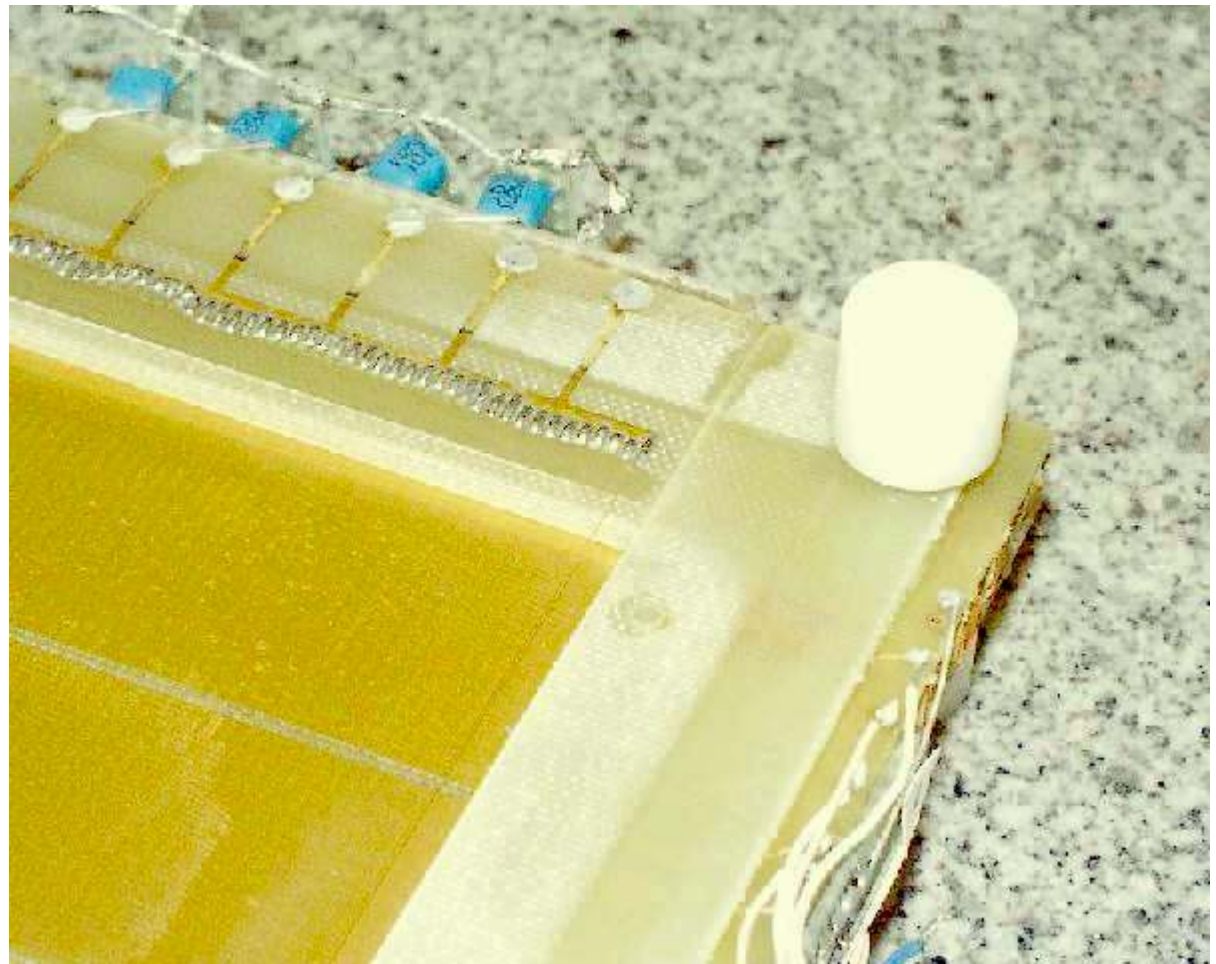
The observed currents are a result of insufficient cleaning the cathode surfaces.

The cathode deposit is observed on all the cathodes. The cathode of gap A2 is shown. The deposit is at a distance of 5-10 mm from the gap border. The deposit layer has the tracks of cleaning procedure.

The brownish spot on the border between two pads is probably result of sparking.

3. An insufficient cleaning procedure can provoke growing deposits.
