UNITED STATES
DEPARTMENT OF THE INTERIOR
GEOLOGICAL SURVEY

FLOODS FROM DAM FAILURES

By John E. Costa

Open-File Report 85-560

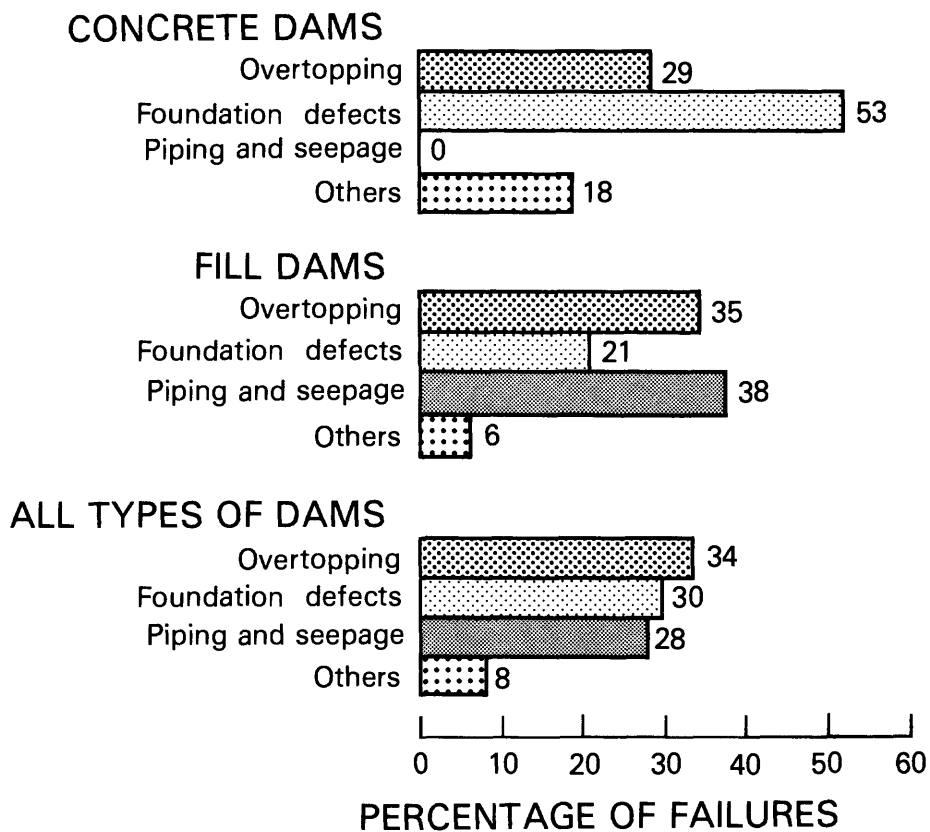
The International Commission on Large Dams compiled a survey of dams more than 15 m in height that failed between 1900 and 1973 (International Commission on Large Dams, 1973). The three main causes of failure were overtopping (inadequate spillway), foundation defects, and piping (fig. 1). The major cause of failure of concrete dams was foundation failure (53 percent), and the major cause of failure of fill or embankment dams was piping and seepage (38 percent). Piping and seepage failures did not occur with any concrete dam. For all dams built, failures by overtopping due to an inadequate spillway (34 percent), foundation defects (30 percent) and piping and seepage (28 percent) have about the same rate of occurrence (fig. 1). These data clearly indicate that the greatest risks of a dam failing originate from ignorance of the magnitude and frequency of extreme floods, and uncertainties of the geologic setting.

Figure 1. Graphs showing causes of failure for different dam types more than 15 meters high (International Commission on Large Dams, 1973).

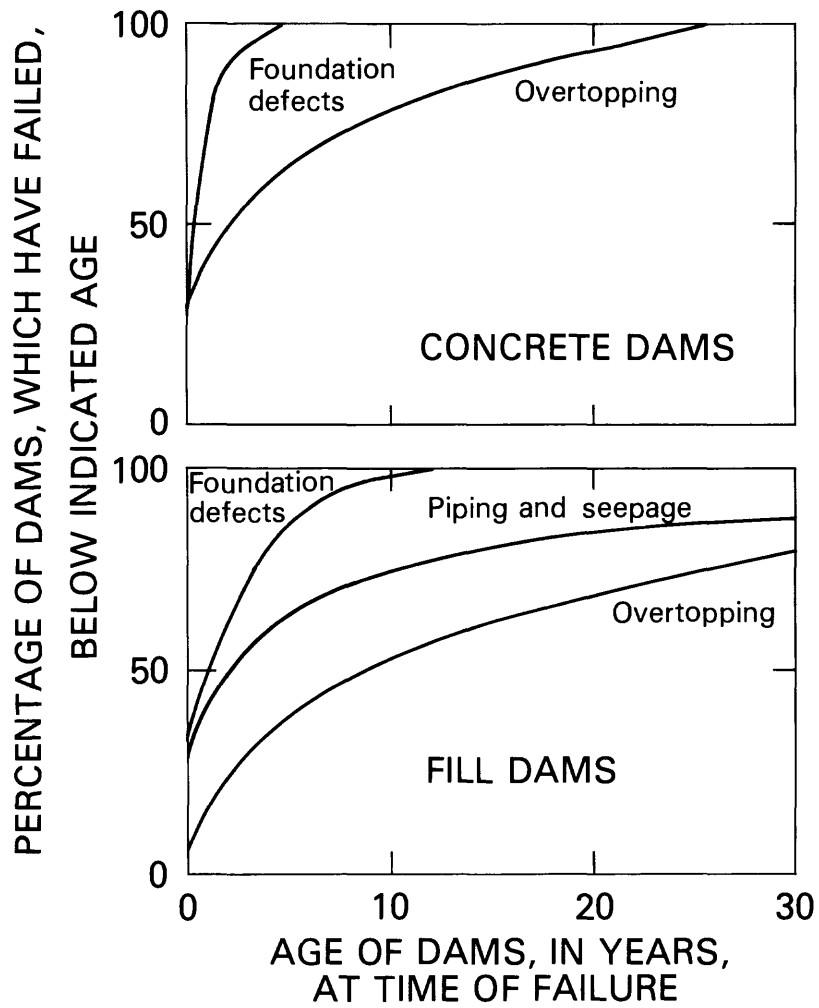
The incidence of the causes of dam failures as a function of the dam's age at the time of failure is shown in figure 2. Foundation failures occur early in a dam's history, whereas other causes take relatively longer to develop. A very large percentage of all dam failures occurs during initial filling since this is the time when design or construction flaws, or latent site defects, will appear.

Figure 2. Graphs showing age of dams at time of failure, for different dam types more than 15 meters high (International Commission on Large Dams, 1973).

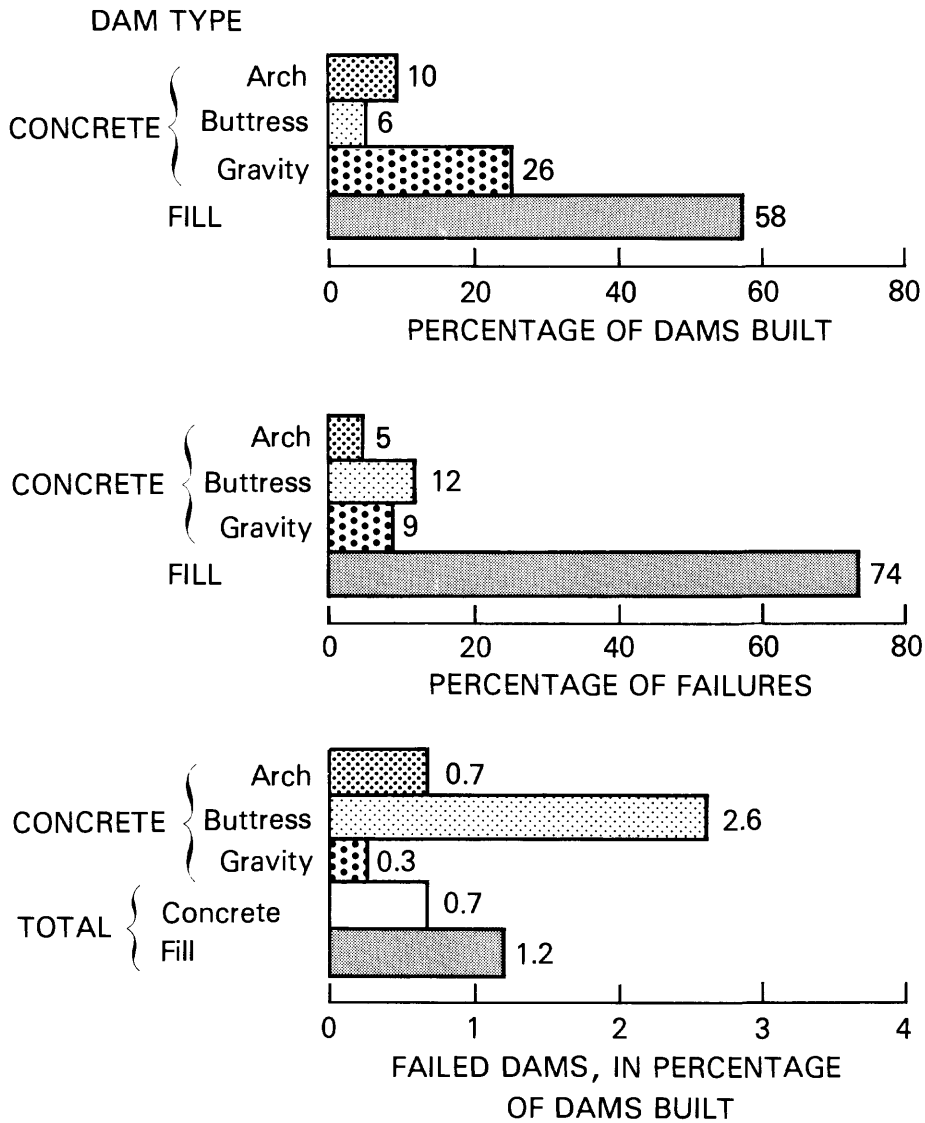
The percentage of different kinds of dams built in western Europe and the United States between 1900 and 1969 is shown in figure 3. Fill or embankment dams (50 percent) were the most numerous types built, gravity dams were second (26 percent). The percentage of failures that occurred for the four different types of dams is summarized in figure 3. Nearly 75 percent of the dams that failed were fill dams. However data in figure 3 also show the failed dams as a percentage of the dams built, and indicates that gravity dams were the safest, followed by arch and fill dams. Buttress dams have the poorest safety record; however, they were the least used.

Figure 3. Graphs showing types of dams built in Western Europe and the United States, and their failure percentage, between 1900-69 (International Commission on Large Dams, 1973).

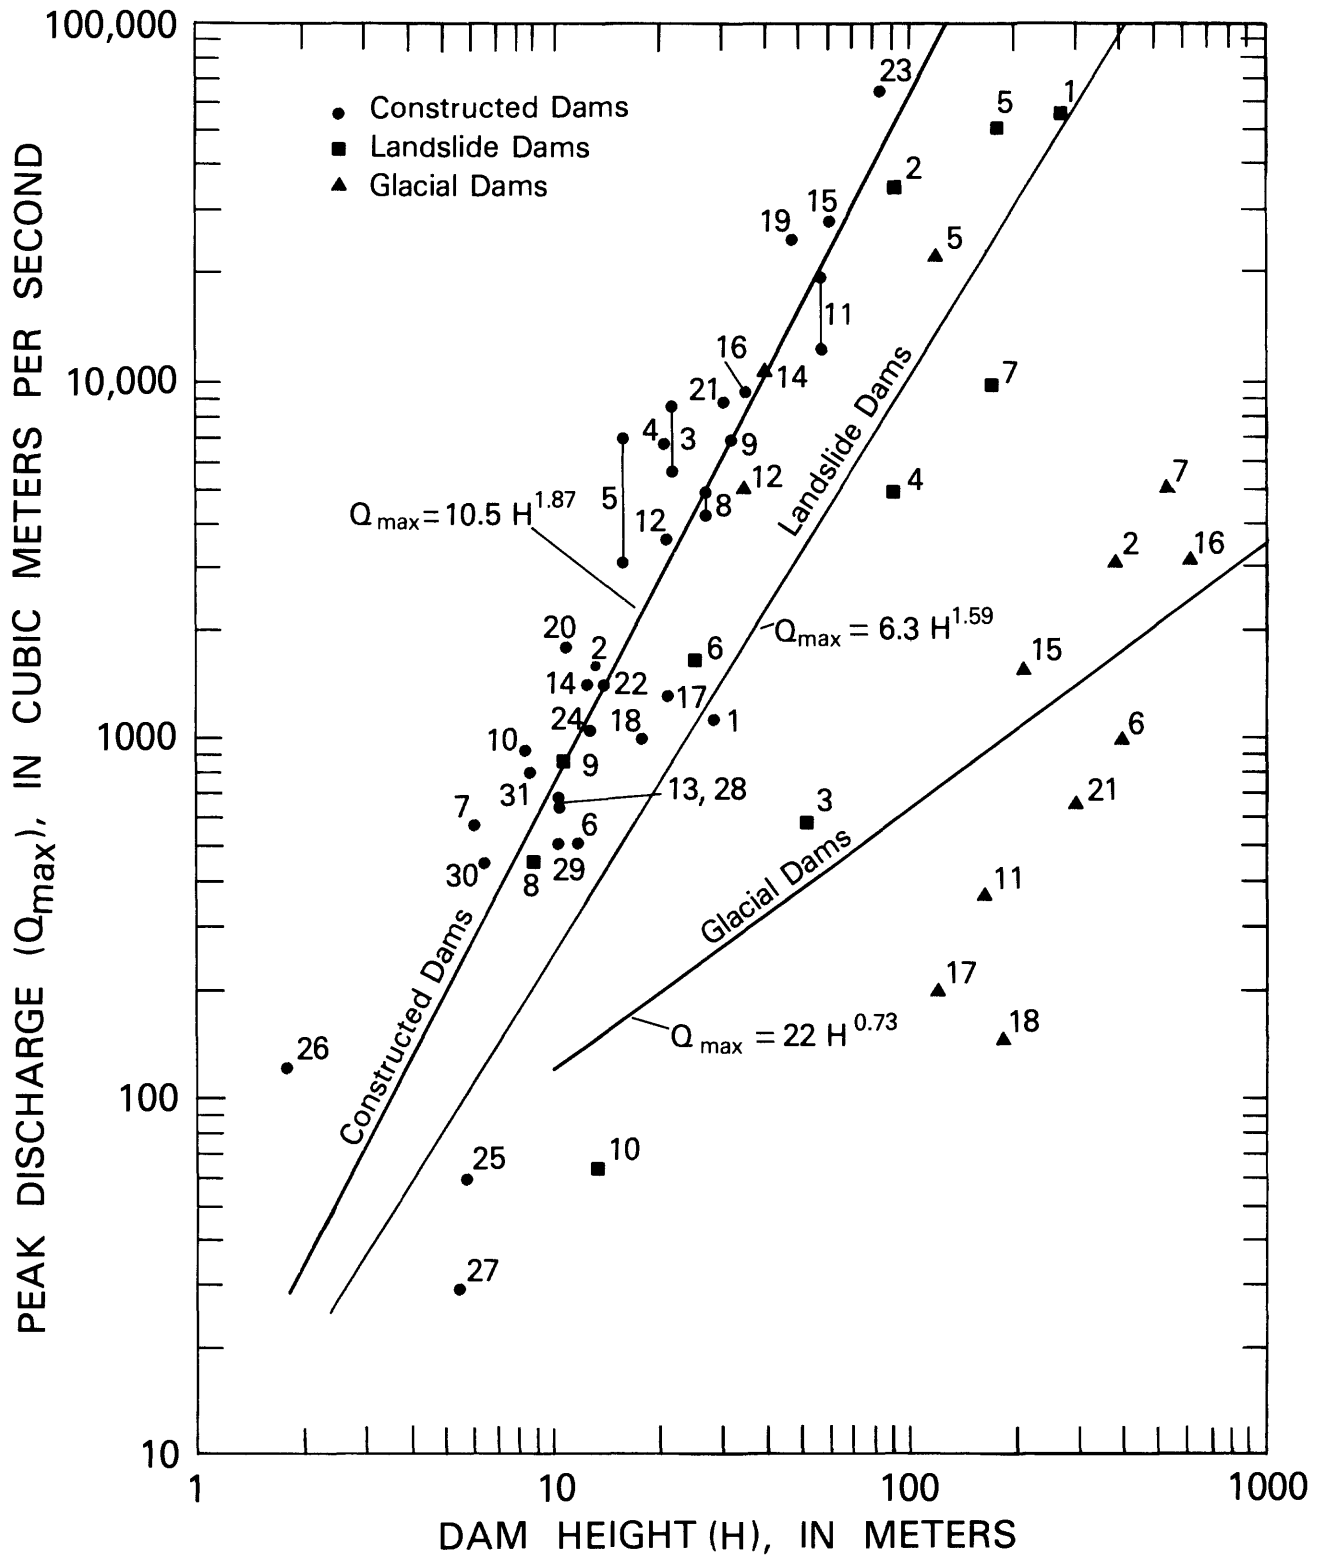
Dam height versus peak discharge for 31 failures of constructed dams between 1.8 and 84 m high is plotted in figure 4 and, listed in table 3. An envelope curve for flood peaks from all the constructed dams has the equation

Accuracy of many peak-discharge estimates from dam failures is questionable, and errors of one order of magnitude may exist. If a rapid, conservative assessment of the potential peak discharge from a failed dam is desired, then the envelope curve (equation 3) could be used. If the purpose is to compare flood peaks from failures of different types of dams, or to reconstruct past flood peaks from old, failed dams for paleohydrological or sedimentological investigations, then a regression equation is more appropriate. A regression equation using dam height as the independent variable has been developed from the data in table 3, and plotted in figure 4. The equation is:

Figure 4. Graph showing dam height (H, in meters) versus peak discharge (Q_{max} in cubic meters per second) for constructed, glacial, and landslide dams with numbers keyed to tables 3, 5 and 6.

When a landslide dam is overtopped, there is commonly much more sediment and debris for water to erode before a full breach is developed. This is probably why flood peaks from failed landslide dams appear to be smaller than constructed dam failures with the same dam height and reservoir volume (figs. 4,5; table 6).

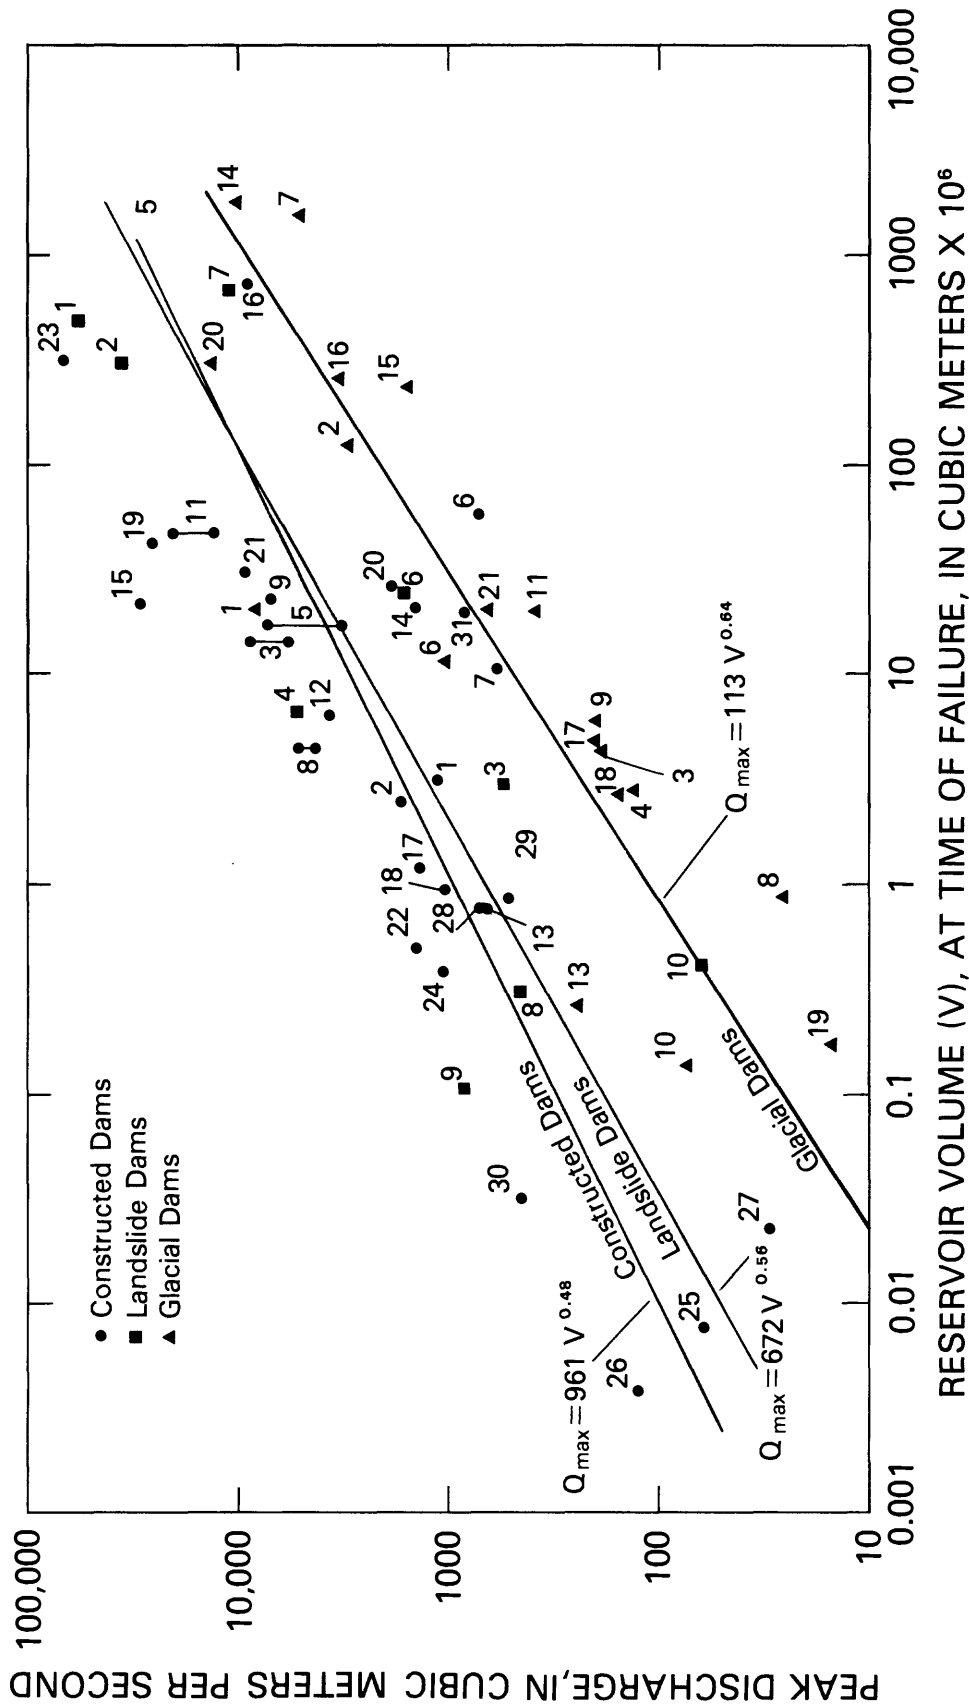
A plot of reservoir volume at time of failure versus peak discharge is shown in figure 5. Sensitivity studies have indicated that reservoir volume as well as dam height are critical factors in the magnitude of dam-failure hydrographs (Hagen, 1982; Petrascheck and Sydler, 1984). An envelope curve encompassing all the data points except two (Malpasset Dam, France, point no. 15, and Cascade Lake Dam, Colorado, point no. 30) has the form:

The Malpasset Dam was a high concrete-arch structure and Cascade Lake Dam was a concrete-gravity dam. These kinds of dams are more susceptible to rapid failure than most of the other types. The sequence of the toppling failure of Cascade Lake Dam, Colorado, is shown in figure 6. The inflow flood peak leading to the failure was 45 percent of the outflow peak following the failure.

Figure 5. Graph showing reservoir volume (V, in m³ x 10⁶) versus peak discharge (Q_{max} in cubic meters per second) for constructed, glacial, and landslide dams with numbers keyed to tables 3, 5 and 6.

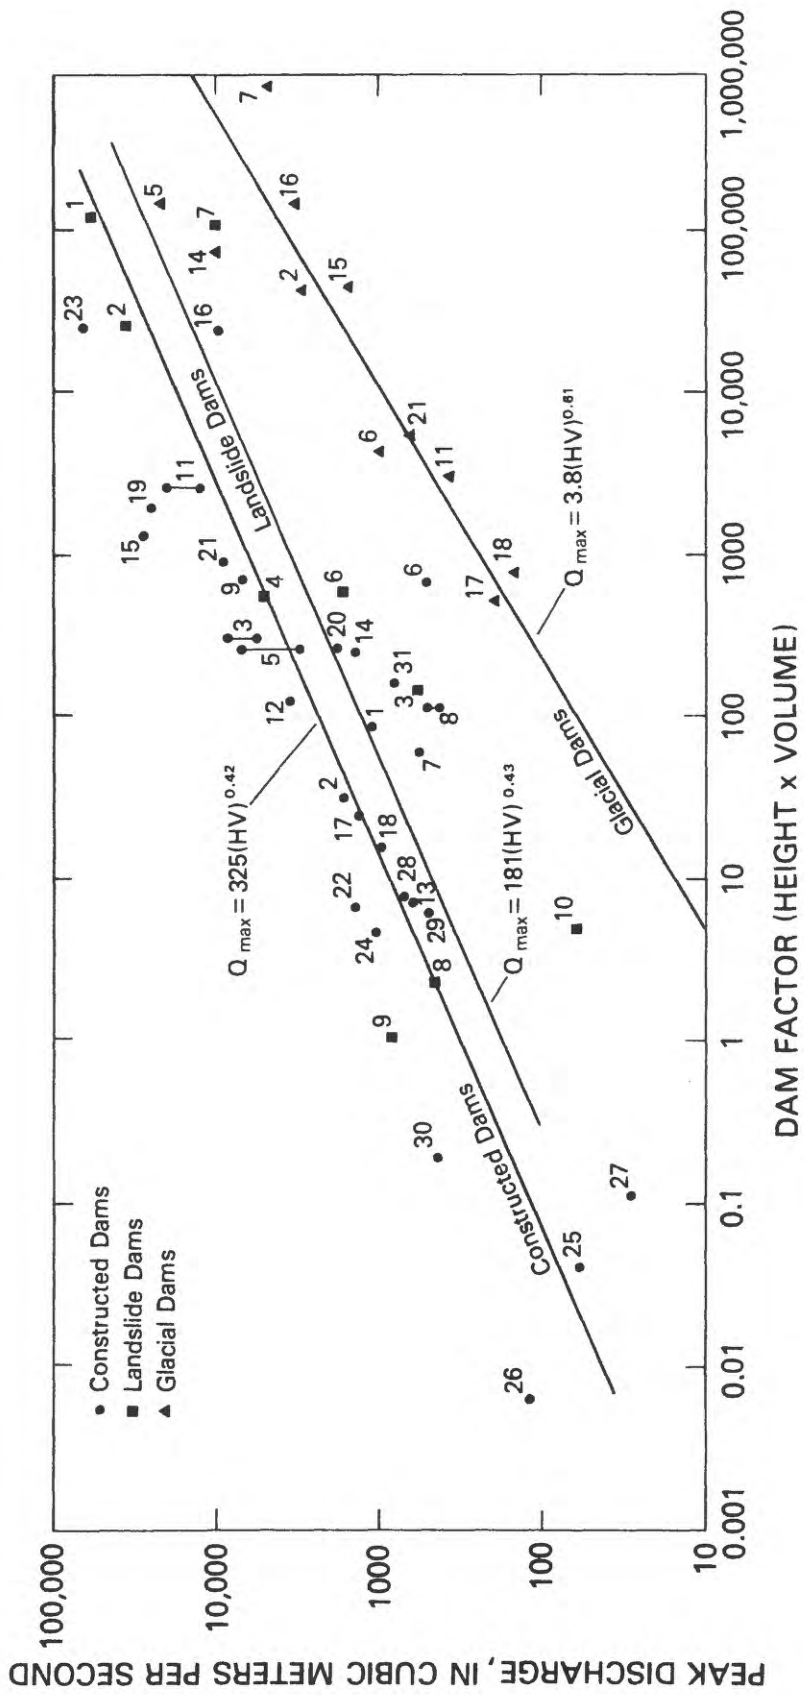
where V is reservoir volume in $m^3 \times 10^6$, and H is dam height, in meters. The regression curve is plotted in figure 7.

Figure 7. Graph showing dam-factor ($H \times V$) versus peak discharge (Q_{max}) for 29 dam failures with numbers keyed to table 3, 5 and 6.

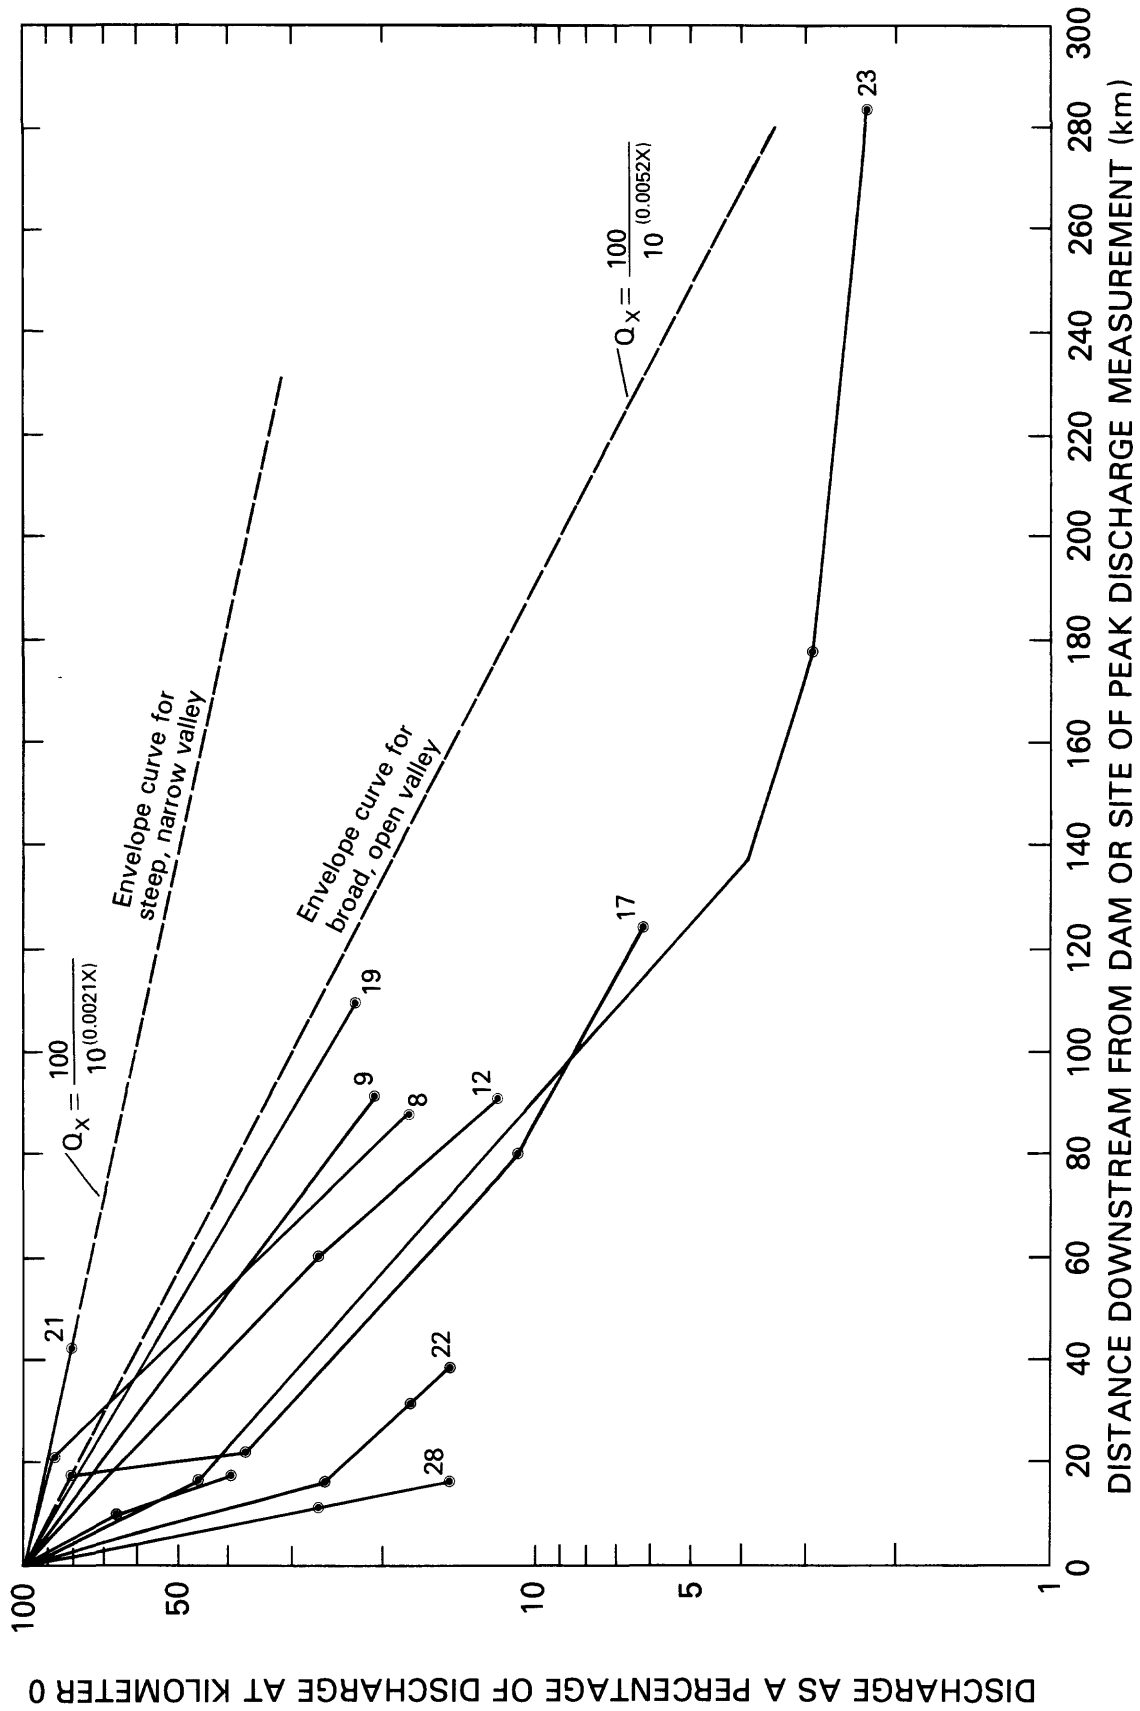
An analysis of some failed dams for which downstream hydraulic measurements were made allows an estimate of attenuation rates based upon empirical data. Available downstream flow data from some failed dams are listed in table 4. Downstream peak discharges are related to peak discharge from the dam failure, and downstream distance from the dam. Attenuation rates as a percentage of upstream discharge are plotted against distance downstream in figure 8. A conservative envelope curve that encompasses all plotted data points for constructed dams, and includes steep, narrow downstream valleys is:

Figure 8. Graph showing attenuation rates of floods from selected dam failures, with numbers keyed to table 4.

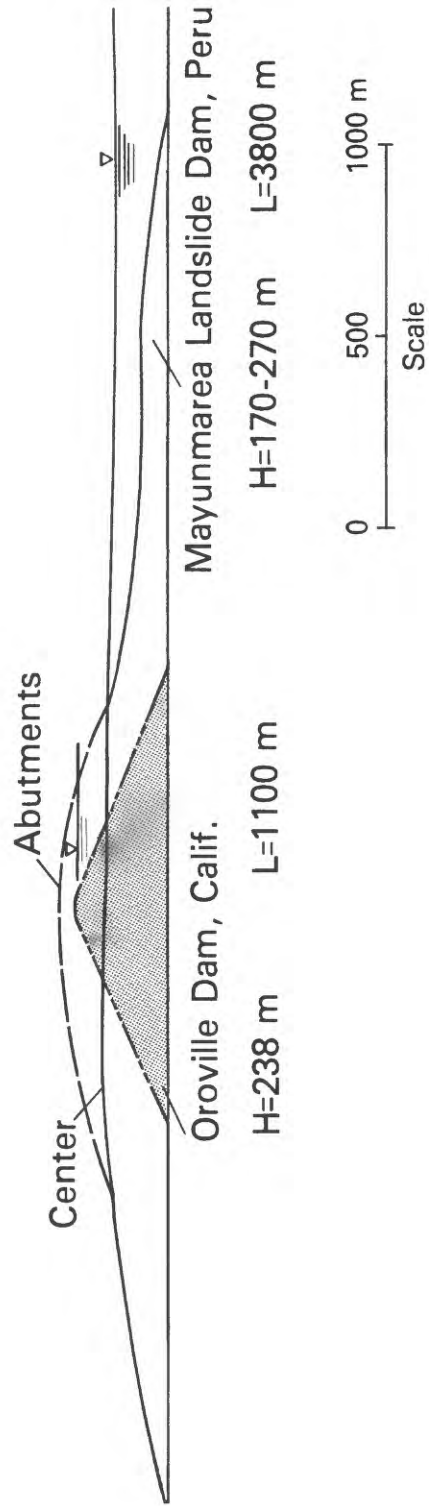
Landslide dams are different from constructed fill dams in several important aspects. Landslide dams are a heterogenous mixture of rock and soil whose permeability can vary greatly. Commonly landslide sediments will plug the valley and flow or slide for some distance down-valley. Landslide dams are typically much wider than constructed dams. For example, the South Nation River landslide dam in Canada was 2.5 km wide (Eden and others, 1971). A transverse section of the Mayunmarca landslide dam in Peru is compared with the Oroville Dam, a large earthfill dam in California in figure 12. The landslide dam is higher at the abutments and almost as high as the constructed dam in the center, but over three times as wide. Landslide dams typically involve large volumes of sediment. The Madison Canyon landslide that dammed the Madison River forming Earthquake Lake in 1959, had a base width five to eight times as great as would have been used in building a rock-fill dam of the same height (Knight and Bennett, 1960).

Figure 12. Cross-section of Mayunmarca landslide dam, Peru, compared to the maximum cross-section of a large earth-fill dam at Oroville, California. (from Lee and Duncan, 1975).

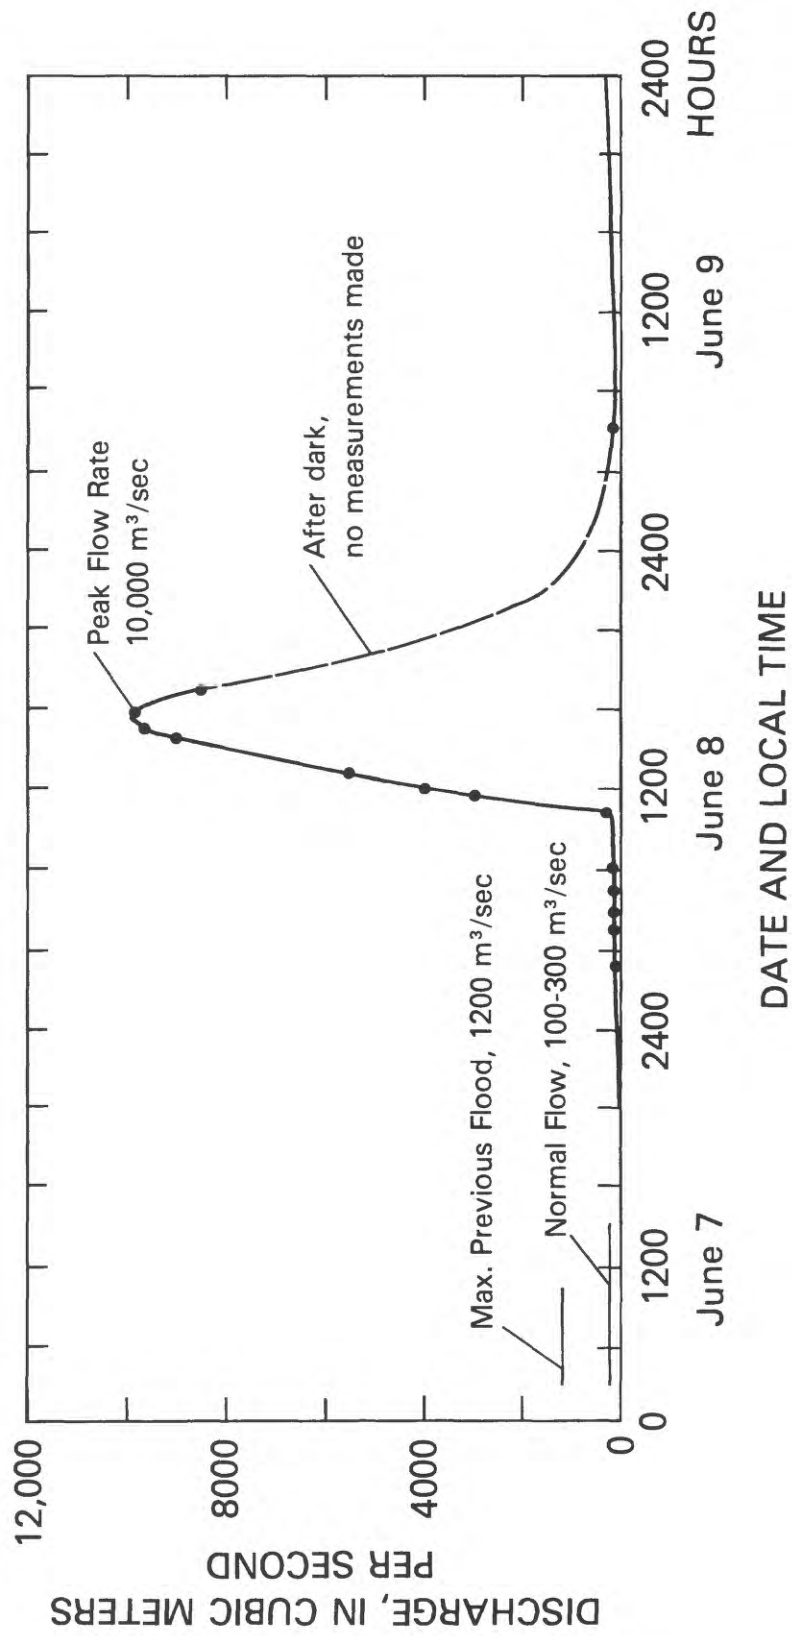
Hydrographs resulting from landslide dam failures depend on the rate of breach erosion and reservoir characteristics. A hydrograph for the 1974 Mayunmarca landslide dam failure in Peru is shown in figure 13.

Figure 13. Hydrograph of discharge resulting from the 1974 failure of Mayunmarca landslide dam, Peru. (from Lee and Duncan, 1975).
