Performance of steel structures during the 1994 Northridge earthquake

**Robert Tremblay, Peter Timler, Michel Bruneau, and
André Filiatrault**

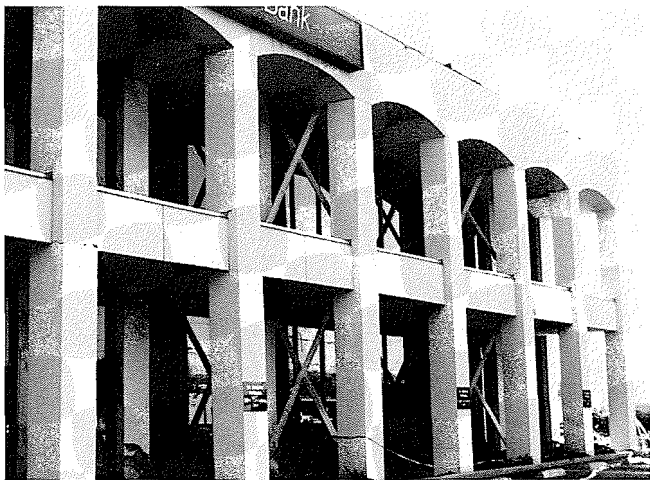
bracing members (Fig. 5). At the base of the columns of the X-braced bays, evidence of uplift could be observed, as the tiles on the ground and the stucco covering the columns were damaged (Fig. 6). This suggests that neither the anchorage nor the brace connecting plates could sustain the load that developed in the braces.

Fig. 5. First Interstate Bank Building in Northridge: buckling of connecting plate at brace intersection.

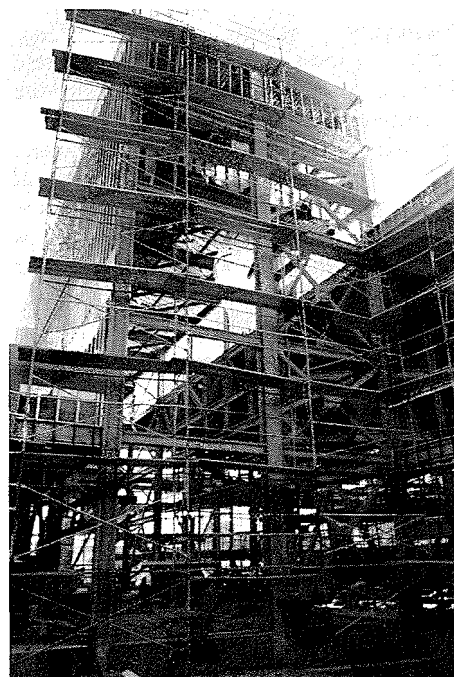
Fig. 7. Student Union Building at the California State University at Northridge: exterior view of building bracing system.

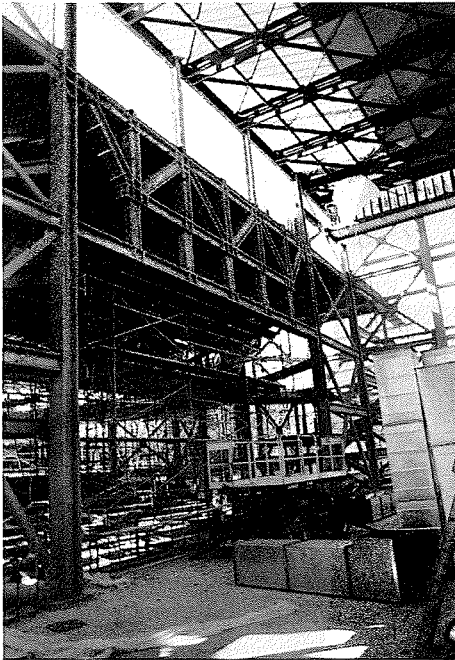
Fig. 8. Student Union Building at the California State University at Northridge: interior view of building bracing and details.

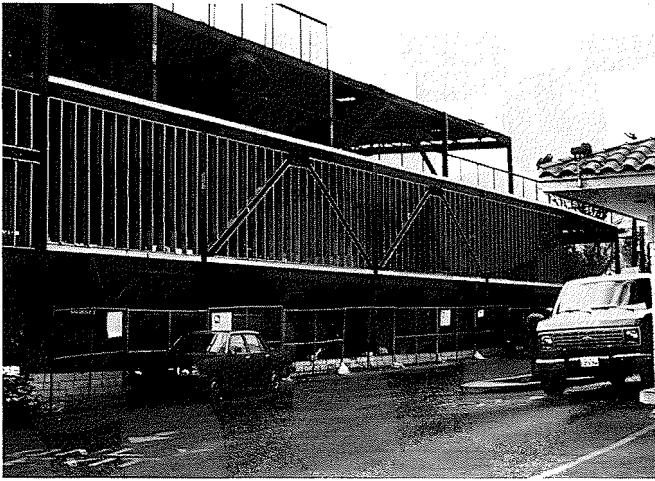
Fig. 12. Three-storey building under construction in Van Nuys: chevron bracing on the north wall.

On Sepuvela Boulevard near Victory Boulevard in Van Nuys, 8 km southeast of the epicenter, a three-storey building was under construction when the earthquake struck. Only the first floor slab was poured at that time. In the north-south direction, the frame was three bays wide with the center bay being a moment resisting frame. Single-bay inverted V chevron bracings were provided along the north and south exterior walls for resisting lateral loads in the other principal direction (Fig. 12). The bracing bays were 10 m wide and the storey height was approximately equal to 3.6 m.

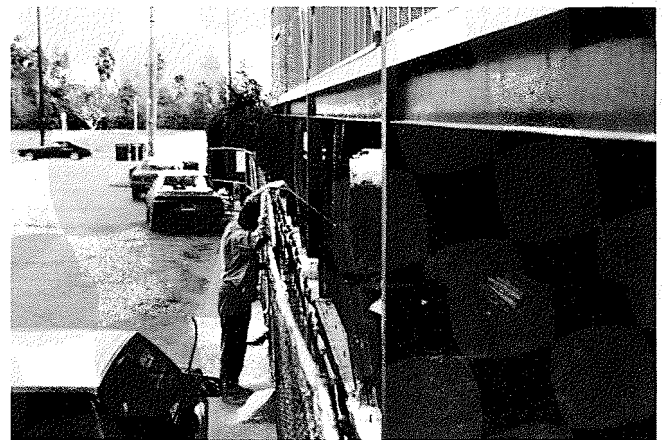
Fig. 14. Three-storey building under construction in Van Nuys: undamaged beams at the second level on the north wall.

buckled shape, which indicates that both braces likely yielded in tension during the ground shaking. These members were made from back-to-back channels, 152 mm in depth and 76 mm in width, assembled by means of 10 mm spacers at quarter span. Though an unbalanced vertical force likely developed at the apex of the V at mid-span of the beams, no signs of plastic deformation could be observed along the beams (Fig. 14). The moment resisting frames in the north-south direction did not suffer any visible damage.

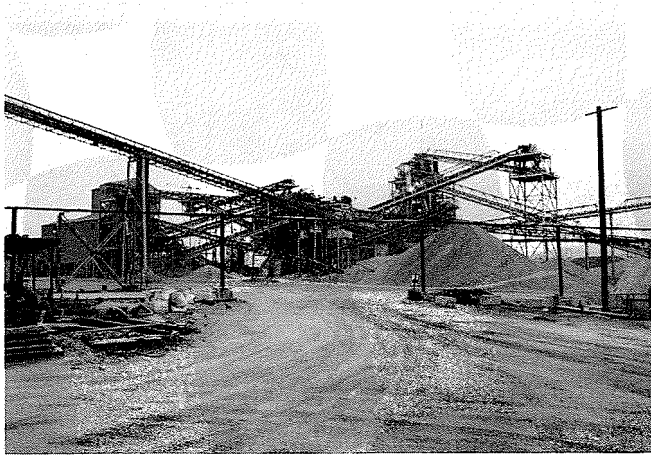
Fig. 19. Asphalt and rock plant: typical conveyor and truss system.

There were no gallery, tower, or conveyor collapses at this site even though the shaking was reported to have rattled the structures intensely. Some evidence of elastic deformation in the bracing as well as minor foundation cracking at column braces were also reported. Numerous anchor bolt elongations of the order of 3 mm had been discovered and one 19 mm diameter anchor displayed a tensile brittle fracture. Remains of this bolt were discovered some 60 m away. Overall the plant sustained only nominal damage. After rectification, it was operational within four hours of power resumption.

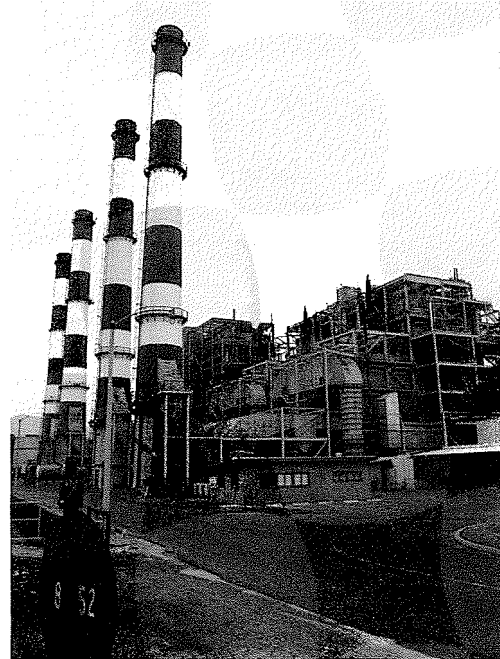
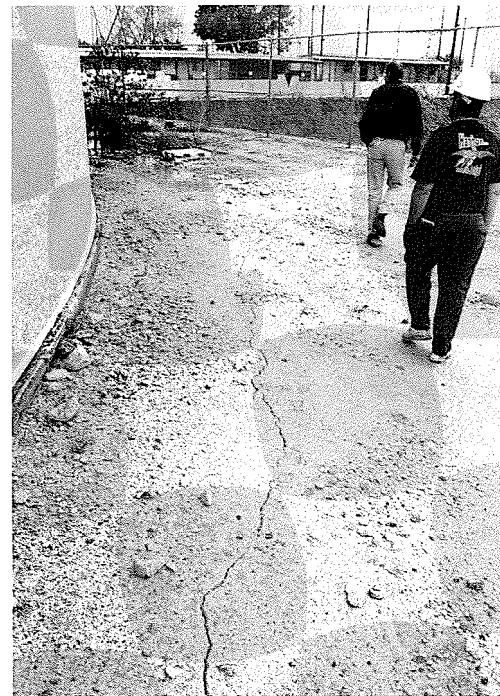
A 350 MW generating station, located approximately 15 km from the epicenter, again in the Sun Valley district, was also visited. It had been reported to have experienced intense shaking. This facility came on grid as the emergency power source following disruption to the electrical service caused by the main shock of the earthquake. The plant's boilers are fuelled by natural gas and are each supported by separate six-storey concentrically braced structures (Fig. 20). Plant personnel reported essentially no structural damage. It is interesting to note that the 70 m high stacks constructed of redwood cedar with stucco finish and brick lining also remained free of damage. A 24 m diameter by 15 m high domestic water tank, which was nearly full at the time of the main shock, exhibited nominal foundation movement as evidenced by the circumferential cracking in the soil (Fig. 21). This movement resulted in a minor leak in a 50 mm diameter discharge line.

Fig. 20. Department of Water and Power San Fernando Generating Station: boiler structures.

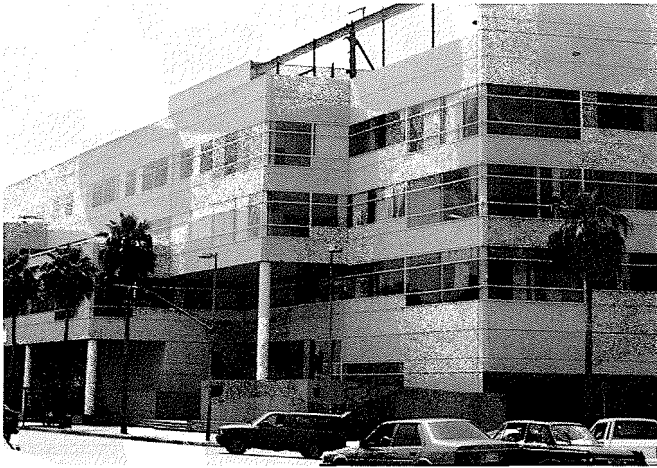
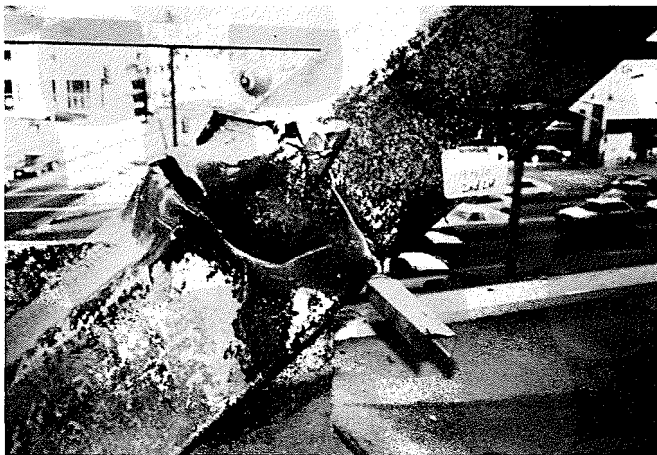
Fig. 22. Four-storey commercial office structure: global view.

Fig. 24. Four-storey commercial office structure: local failure of hollow structural brace at center.

failures. Most of the severe damage was limited to the north-south oriented braced bays at the second floor. This potentially implies that the demand-to-capacity ratio of the braces was somewhat higher at the second floor (Bonneville 1994) and that the existing chevron braced system was not capable of redistributing forces to other levels after the second-storey failures occurred. Significant ductility problems were exhibited in the HSS 305 × 305 × 9.5 mm (12 × 12 × 3/8 in.) tubular braces. Many of the failures found were attributed to local plate instability of the section because of the high width-to-thickness ratios of the walls of the steel tubes. Local buckling was isolated either the end connection or the center of the brace (Figs. 23 and 24). Ruptures in the braces were caused by high stress, low cycle fatigue resulting in the formation of a brittle crack at crimped wall failures from local instability. One brace had ruptured completely through its cross section (Fig. 25).

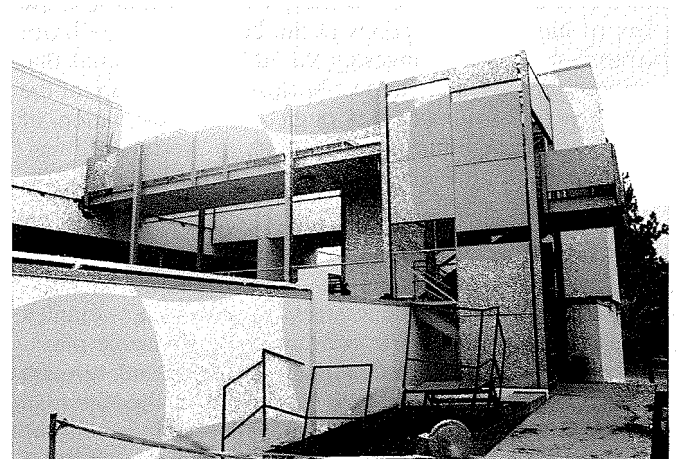
Fig. 36. Holy Cross Hospital administration building: elevator and suspended walkway in background.

framed building located in the Mission Hills district. The street bracing system was not identified because of building finish cover but possibly contained moment resisting frames in some areas. Entry to the structure was restricted to only record retrieval following initial assessment and subsequent decision for its future demolition. A steel framed (likely diagonally braced) elevator shaft and suspended third floor walkway (behind stair tower and walkway in background of Fig. 36) had separated from the main building by some 200–250 mm due to column anchor bolt failures in a reinforced masonry wall (Fig. 37).

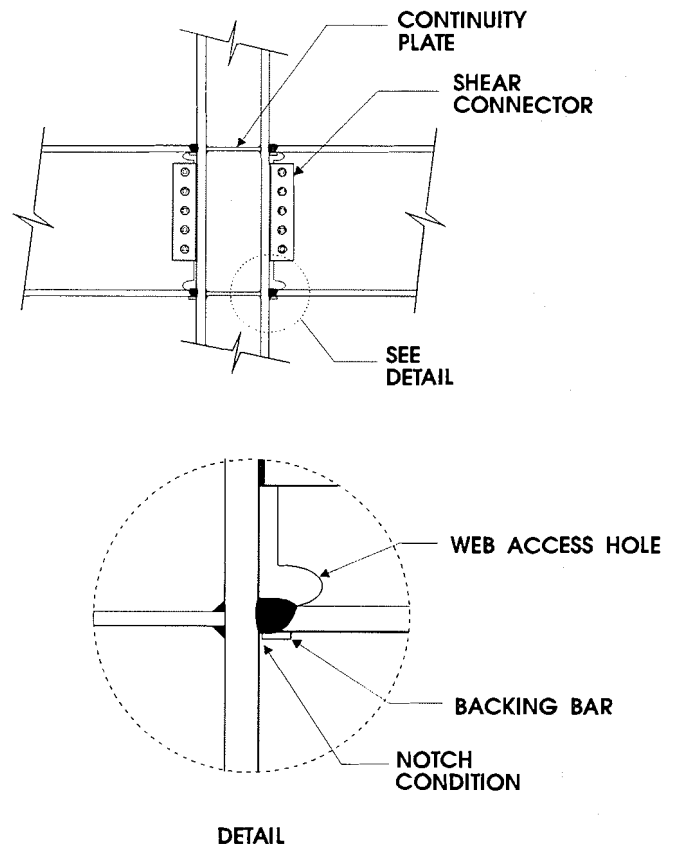
All fractured joints were of the welded flange and bolted web type, as shown in Fig. 43. Some had their vertical shear connectors partially welded to the beam web. Each discovered failure had full-penetration weld fractures in the bottom flange, very few had these fractures in the top flange. In all cases, there was little or no evidence that plastic hinging had developed in the beams prior to weld fracture. Some damaged connections also exhibited vertical cracking through the shear connector or shearing of the web bolts. It is believed that this secondary mode of failure developed as the beam rotated relative to the face of the column after fracture of the beam flange weld had occurred.

Fig. 43. Typical welded flange and bolted web beam-column connection in moment resisting frames.

rates are also seen as possible contributors to weld failures. In addition, left-in-place steel backing bars create a notchlike condition (Fig. 43) that may have led to stress concentration in the welds and initiation of cracking.

In March 1994, a special task committee of the American Iron Steel Construction (AISC) proposed interim recommendations for the repair of damaged connections and the design of new moment resisting frames (AISC 1994a). For repair, it was suggested that any cracked material or weld be removed and replaced by new steel material or welding. Of course, fabrication and welding practices were to strictly meet applicable code requirements. In addition, based on the current state of knowledge at that time, three options were proposed to enhance the performance of the joint. These are illustrated in Fig. 45 for the connection shown in Fig. 43.

Firstly, it was suggested that the backing bars of the beam flange welds be removed, the weld root region backgouged and rewelded, and, subsequently, a reinforcing fillet weld be applied. Second, the beam web was to be welded directly to the column or, alternatively, to the vertical shear connectors as shown in Fig. 45. The third correction consisted in adding flange reinforcement plates, either vertical ribs or cover plates, to help transferring to the column the axial loads acting in the beam flanges. The decision of using only one or more of those three schemes was left to the engineer. Examples of these repair procedures are presented by Sabol (1994) and by Tide (1994). For the design of new structures, AISC recommended to implement these repair provisions when

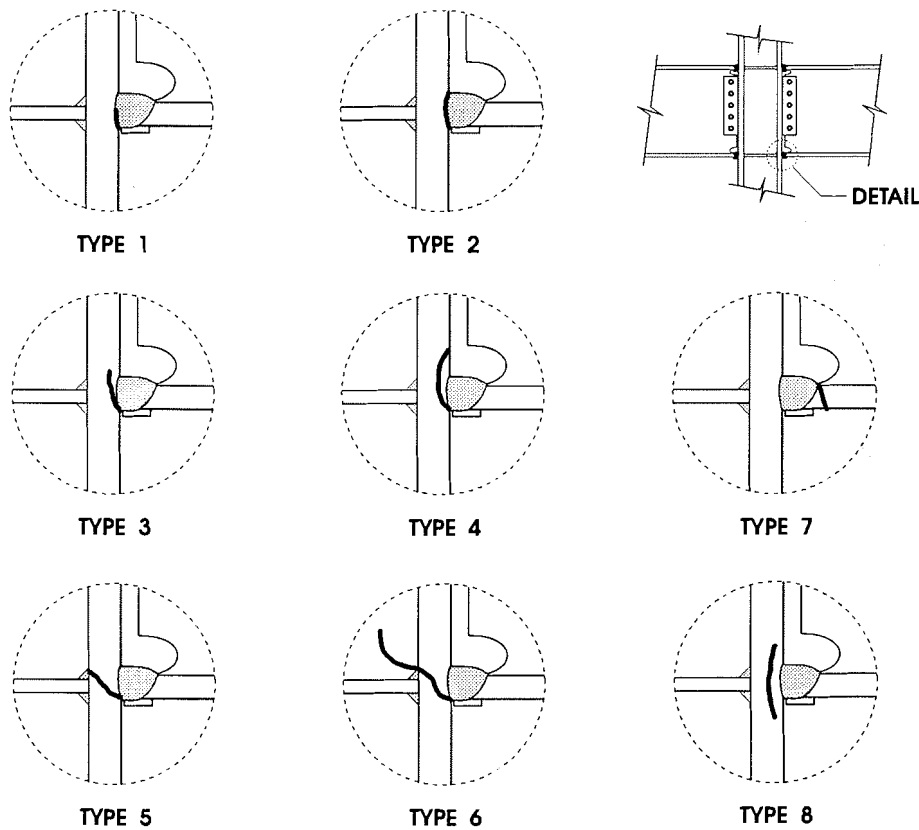
Figure 44 shows some of the failure modes that have been observed at the bottom flange of the beams. Reports indicate that most cracking initiated in the root pass of the weld, near the steel back-up bar. Type 1 and 2 cracks were very frequent. Failures of type 2 could be readily identified in the field. Type 1 failures can also be detected through visual

inspection as the backing bar separated from the column face (Miller 1994). Type 3 and 4 failures are similar to types 1 and 2, but crack propagation took place into the column flange rather than at the interface between the weld and the column flange material. Type 3 cracks can be detected only by means of ultrasonic inspection, as these cracks do not exit the column flange surface.

In other connections, cracks developed across the column flange (type 5) and, in some cases, propagated further into the column web (type 6) (see also Figs. 40–42). Miller (1994) reports that some columns completely fractured horizontally. A few connections also exhibited a crack across the beam flange (type 7) and, according to Bertero et al. (1994), one case of column lamellar tearing (type 8) has been reported.

Fig. 44. Typical failure modes in beam flange to column connections (adapted from Bertero et al. 1994; Miller 1994; Ross and Mahin 1994).

Cracking of the beam flange welds has been mainly attributed to overstressing of the welds and to weld defects. During the welding process, significant stresses can be induced in the welds because moment connections are highly restrained. Upon loading, welds become overstressed because of the inadequacy of the bolted web connection to transfer bending moments; at the column face, increased axial stresses develop in the beam flanges as the full plastic moment of the beam must be entirely resisted by the flanges only. The fact that actual beam material may exhibit lower tensile to yield strength ratios could also have contributed in overloading the welds of the beam flanges.
