Irradiation tests of the ALTERA SRAM based FPGA and fault tolerant design concepts

Abstract

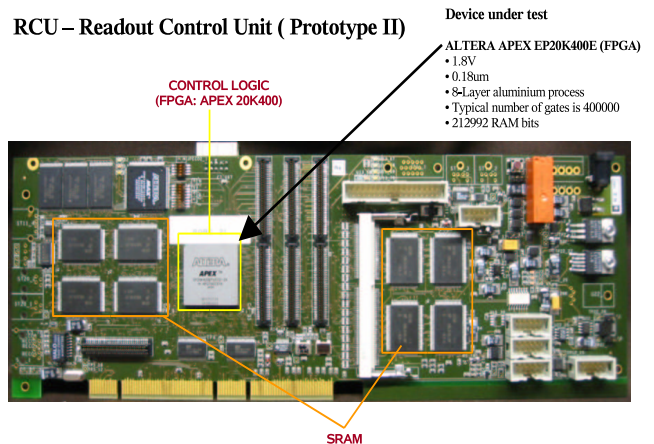
Figure 1: RCU prototype II layout. SRAM is organized in 2 banks with separate data and address lines. The control logic is contained in the on board FPGA (DUT)

The readout electronics for the ALICE TPC detector consists of 4356 front-end cards (FECs) that contain the complete chain to readout the signals coming from 570132 pads. The front-end cards are grouped in 216 readout partitions, each controlled by a Readout Control Unit [2] fig. 1(RCU) that interfaces the FECs to the DAQ, the Trigger, and the Detector Control System. Each RCU contains the Altera APEX EP20K400E FPGA we have tested.

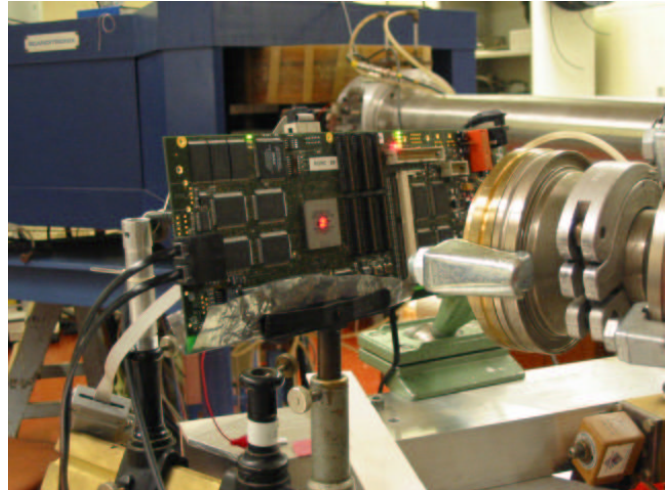
Figure 2: RCU prototype card mounted in the beam path. A laser is used to align the FPGA correctly

The DUT, which is mounted on the RCU prototype, is placed in the proton beam with its top surface perpendicular to the beam axis, see fig. 2. It is in turn connected to another RCU card in the PCI bus of a Linux PC (experiment PC) running software for communication and data collection from the DUT. The communication protocol between the two RCU cards is the Slow Control Serial Network [5](SCSN). The SCSN consists of a VHDL block design on the FPGA placed on both RCU cards. This means that there is a possibility of experiencing single event upsets in the SCSN design as well. In future version the communication handling will be moved out of the DUT. For now, a periodic loop back of the output of the SCSN is done to check for upsets related to the communication. Another Linux PC is placed in the control room and is used for

The alignment of the DUT is done by using a laser mirrored in parallel to the beam path.

A camera is placed in the experiment hall and with the help of a monitor in the control room a ceramic viewer with a marking spot is aligned in the beam. A proton beam in the order 10 times the test intensities illuminates the viewer. The marking spot on the viewer is used as a reference for the laser so that the DUT can be securely mounted in the beam path when the beam is off.

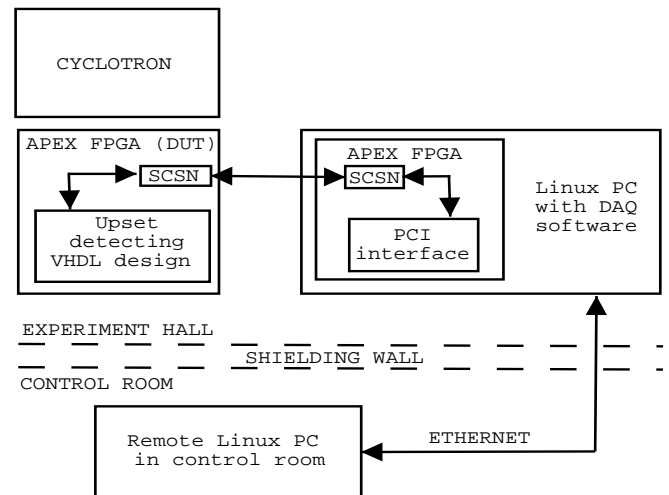
Figure 3: schematic showing an overview of the basic architecture of the test setup

remote control of the irradiation test. Both PCs are connected to Internet and the test can in principle be run from anywhere. In fig. 3 a schematic overview of the setup is shown.

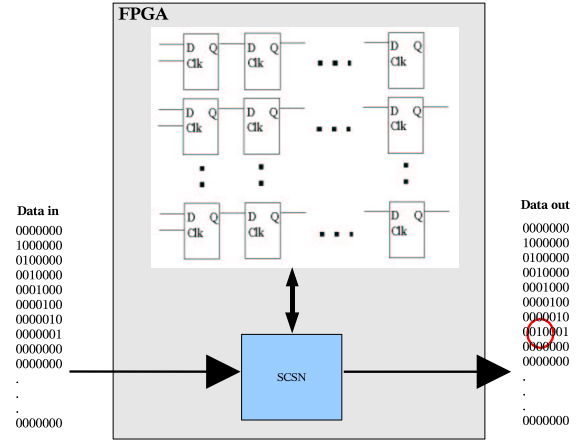
Figure 4: The shift register is implemented in the logic elements of the FPGA. A fixed pattern is shifted through the register and is compared for expected value at the output. The shift register is 32 bit wide and 400 bit long

The ALTERA FPGA tested does not offer the option to read out the content of the configuration RAM. Therefore the configuration upsets have to be detected indirectly using a design implemented in VHDL code. This means that a bit flip or an error observed will reflect the change in logic due to an upset in a configuration bit, and not the configuration bit flip itself. A 100% use of configuration memory bits is very unlikely, thus configuration upsets that will not influence the behavior and therefore not be detectable, can occur. Thus the result will not give an exact number of configuration bit flips, but only an estimate. It is also hard to say if a detectable change in logic is due to a single or a double bit flip in the configuration RAM. A change in the logic caused by a configuration upset or a single bit flip induced directly in the logic will at first glance have the same appearance. It will only be distinguishable by looking at it over time. While a configuration upset will give a permanent change in the logic, until reprogramming of the device, and therefore be reflected as a stuck at error in the read out, a single bit flip will only be present until the next clock cycle loads a new value into the register. Taken in account the above discussed behavior of upsets, a VHDL design to detect both single bit flips in sequential logic and configuration upsets was designed. Since the ALTERA APEX FPGA contains both logic elements and internal RAM, the design should concern both. The design implemented is a 32 bit wide and 400 bit long shift register in the logic elements, see principle schematic in fig. 4, and a 32 bit wide and 4096 bit deep FIFO in the internal RAM blocks. The shift register uses approximately 90% of the logic elements while the number for the internal RAM bits is 60%

A walking one and zero pattern was shifted through both the shift register and the FIFO. The read out pattern from the design is compared with the expected value and if it differs a

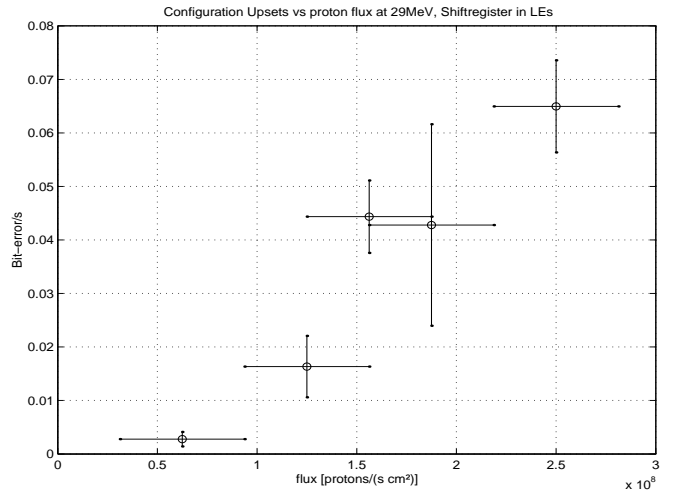
Figure 5: The rate of configuration upsets in logic elements plotted versus the flux

Irradiation of the FPGA was done with a 29MeV proton beam with fluxes ranging from $0.63 \cdot 10^8 - 2.5 \cdot 10^8 p/cm^2 \cdot s$. Several runs were done and the results are plotted in figures fig. 5, fig. 6, fig. 7. The cross-section for the configuration upsets in the logic elements is plotted in fig. 8. The plots for the upsets in the internal RAM is corrected by a factor of 1.7 due to the use of RAM bits is 60%.

a constant value in the cross-section plots. For the configuration upsets in the logic elements we can see the resemblance of a linear plot. However the error bars are considerable due to uncertainties in the measurements.

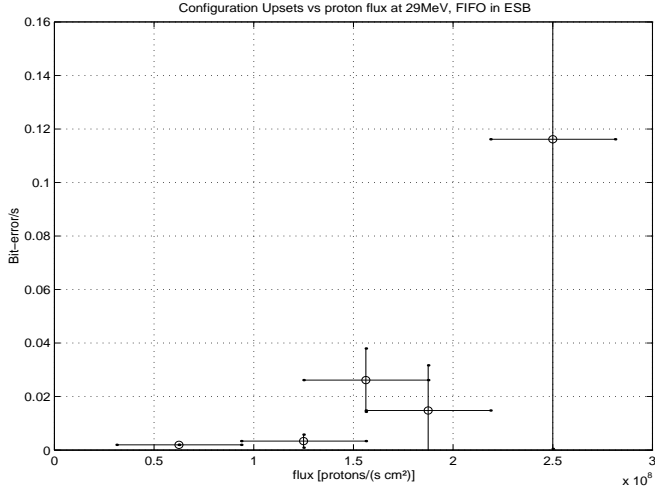
Figure 6: The rate of configuration upsets in internal RAM plotted versus the flux

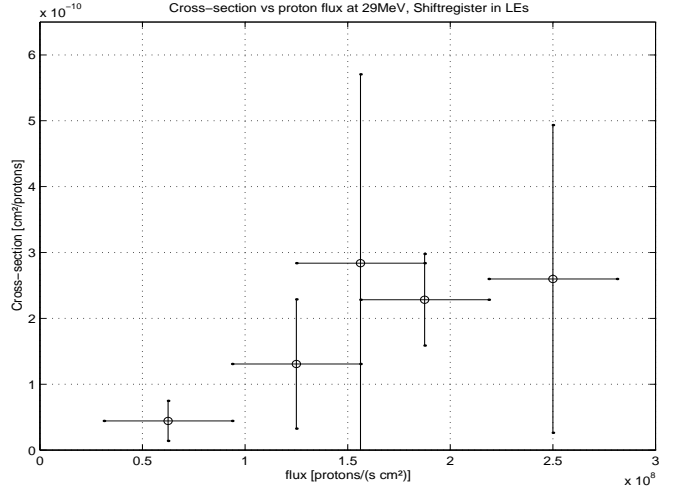
Figure 8: A plot of the cross-section versus the flux for configuration upsets in the logic elements Cross-section $1.9 \times 10^{-10} \pm 0.8 \times 10^{-10} \text{ cm}^2$

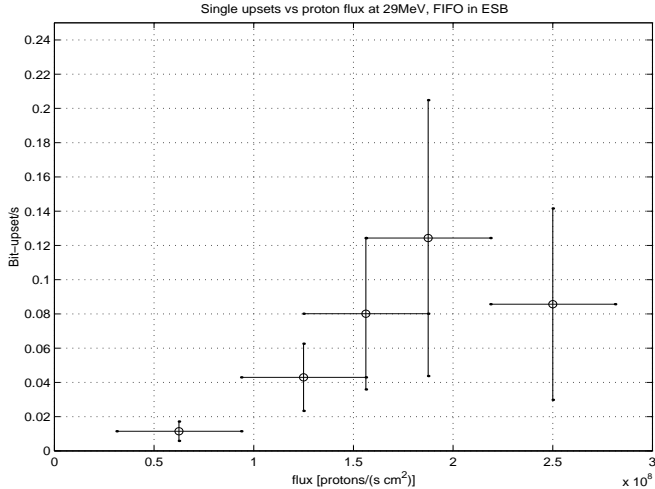
Figure 7: The rate of single upsets in internal RAM plotted versus the flux

For these test single bit flips are discovered in the internal RAM only, and the corresponding cross-section is higher than for the configuration upsets in the logic elements. The reason for this might be that the density of SRAM cells in the ESB blocks are much higher than in the logic elements. And therefore the probability of hitting a SRAM cell in the internal RAM is considerably higher.
